# *A Buyer's Choice Home Inspections*

## Property Inspection Report

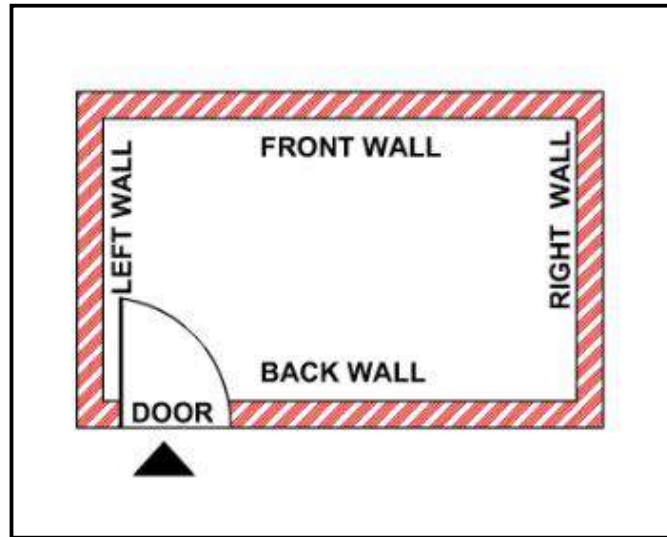
Location defined for walls

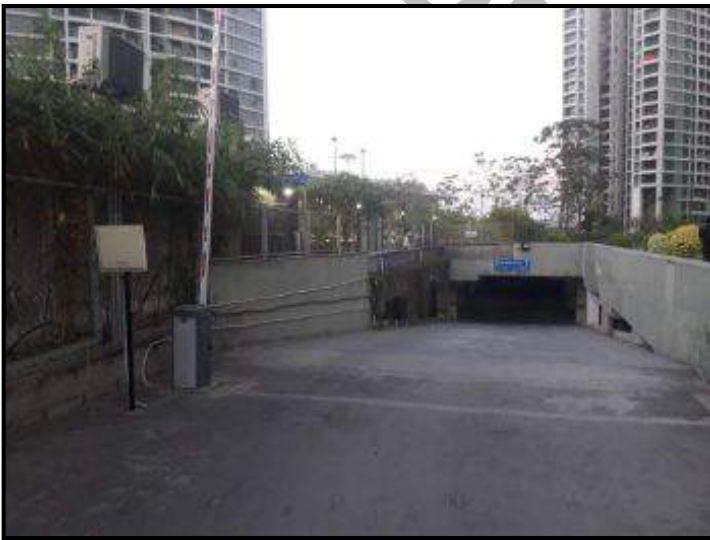
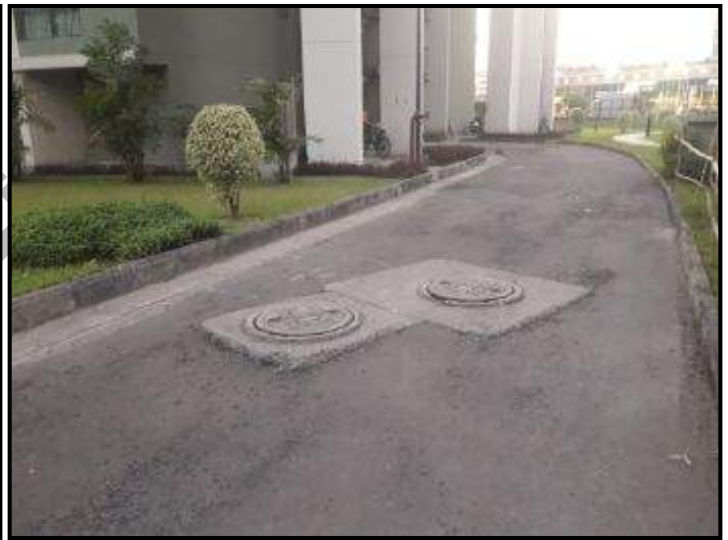
Angle security convex mirror not provided in front of basement ramp Manhole pit not in level with surrounding drive way

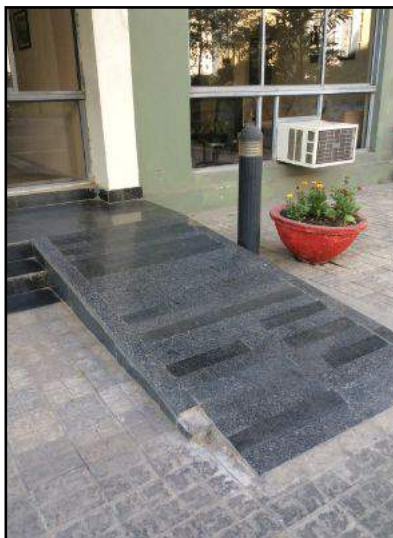
Hand rail not provided at ramp

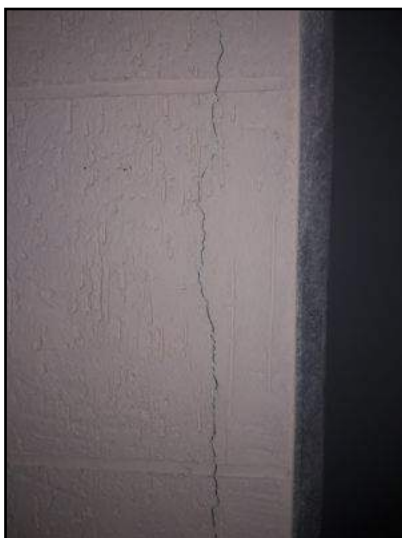
Crack noted on back wall near lift

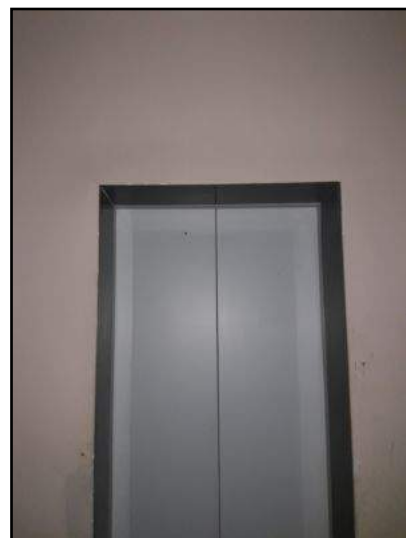
Signage not provided for service lift

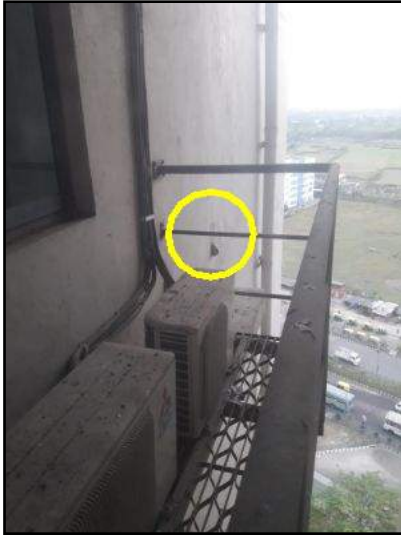
Improper termination of AC drain outlet pipe on exterior wall of apartment near AC outdoor units

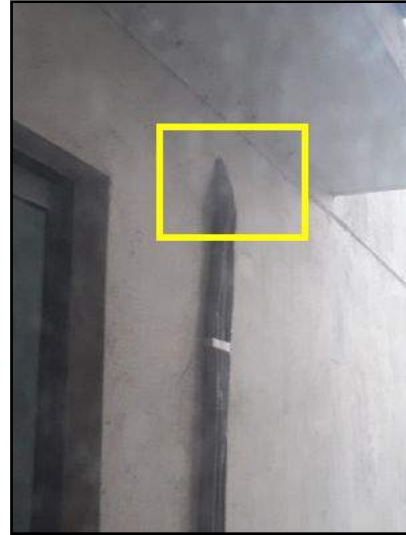
Packing note done around AC pipe sleeve

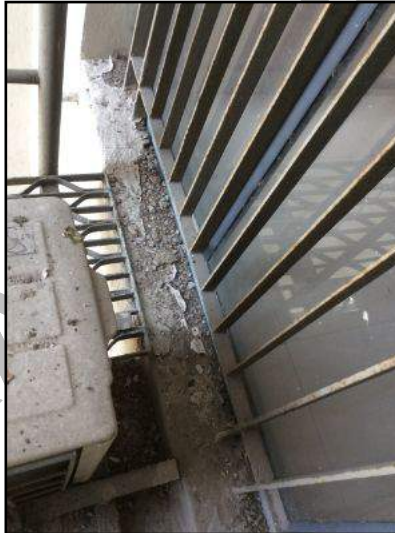
Broken plaster noted on exterior sill of window near entrance door

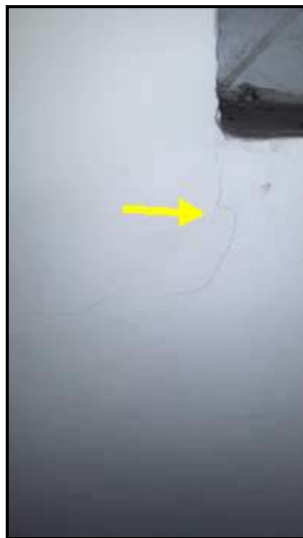
Hairline diagonal crack noted on back wall under left side reveal of window

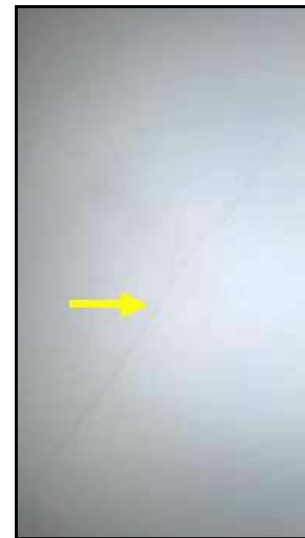
Hairline diagonal crack noted on back wall at mid height to the right side of junction with column

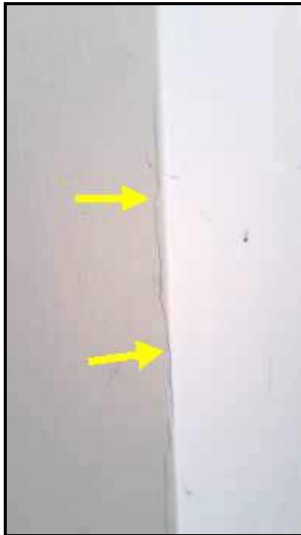
Significant vertical crack noted on front wall corner with right wall

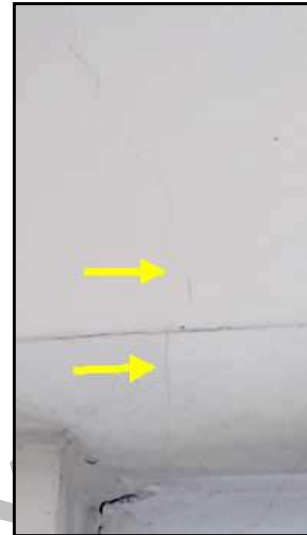
Significant vertical crack noted on front wall beam and on head reveal of balcony sliding door

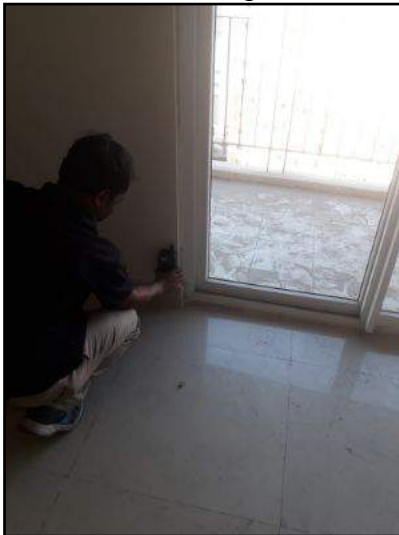
High moisture content on front wall to the left side of balcony door

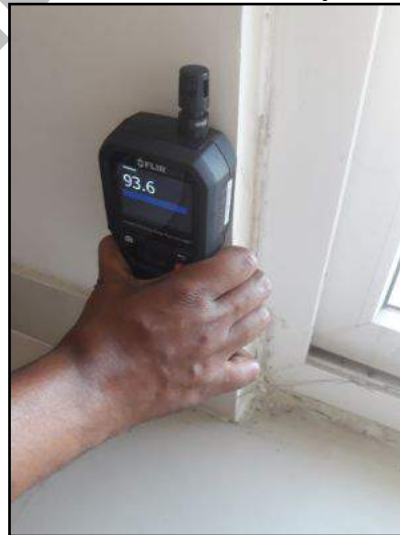
93.6 moisture content

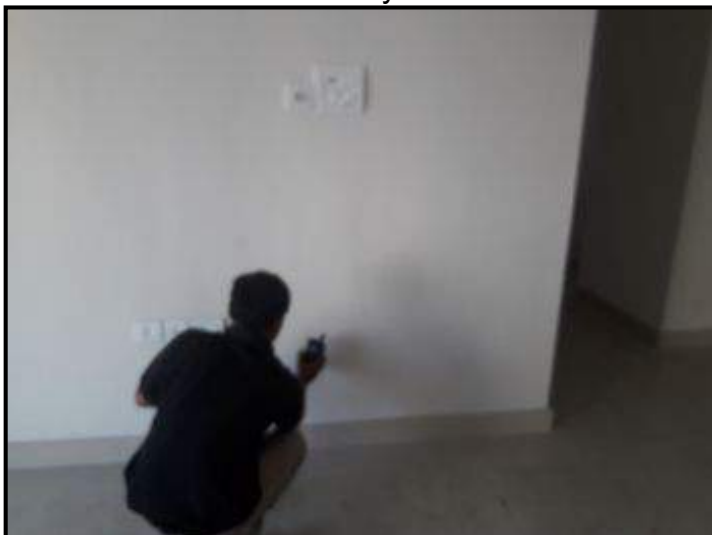
High moisture content on lower portion right wall near telephone socket

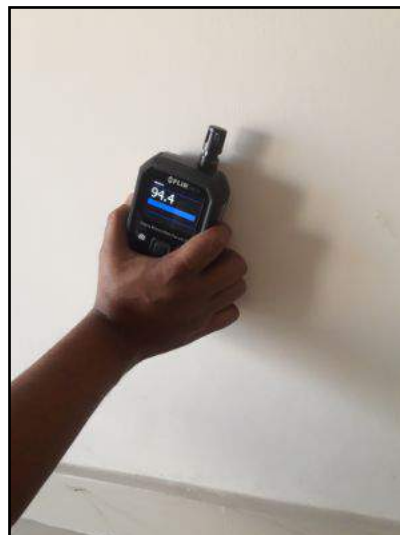
94.4 moisture content

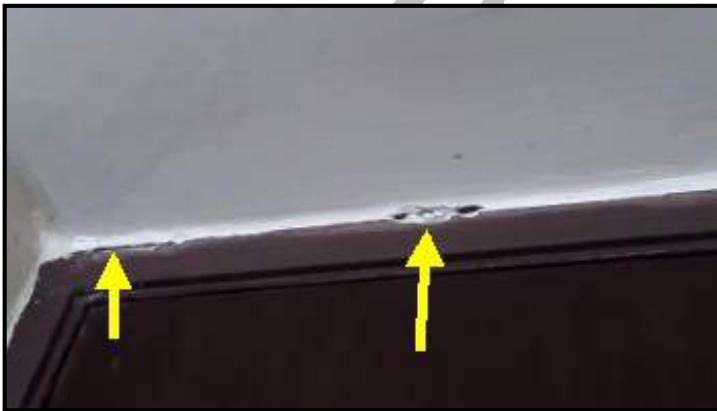
Gap noted at junction of false ceiling and head jamb of entrance door

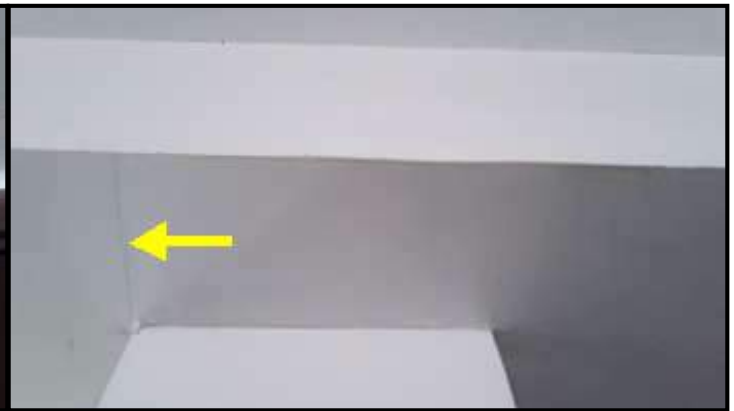
False ceiling board joints are visible

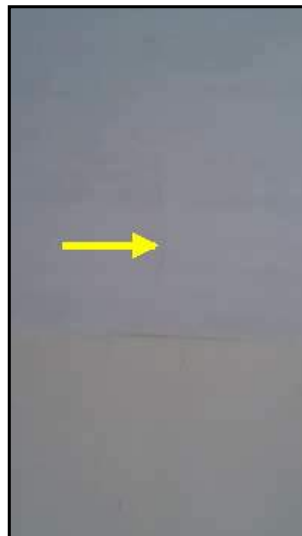
Crack noted on plaster ceiling near left wall above right reveal of left alley opening

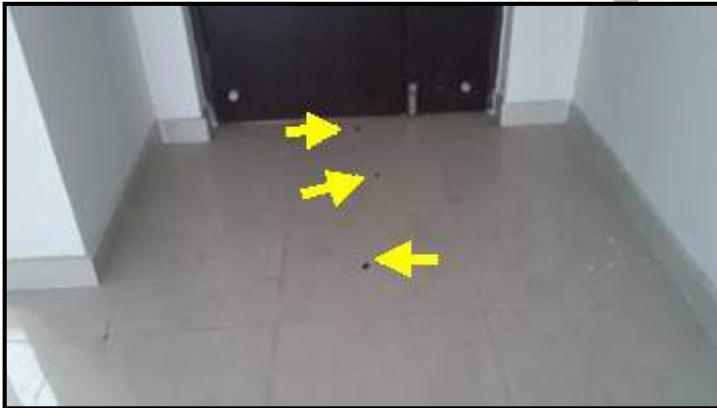
In front of entrance door : All tile except the marked ones are hollow

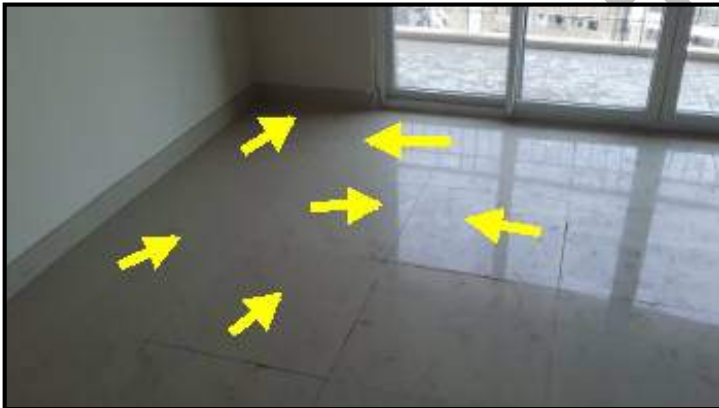
Front wall left corner : Marked tiles are loosely fitted

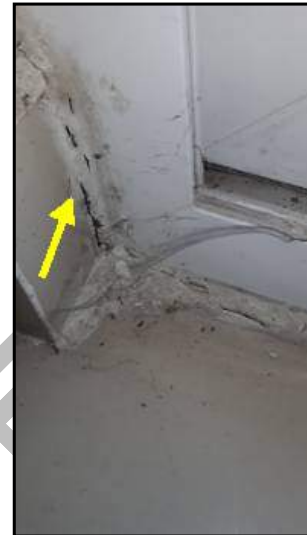
Sealant deterioration at junction of balcony door and skirting

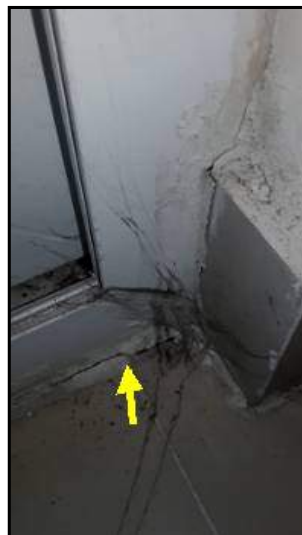
Sealant separation noted at junction of floor tile and balcony door

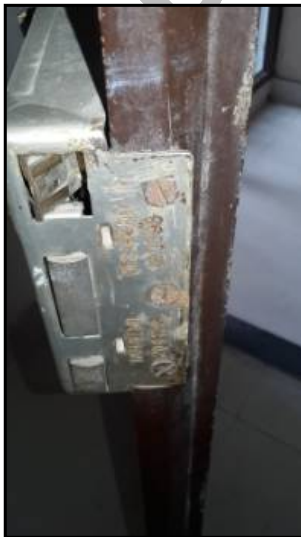
Rusted screws noted on lock

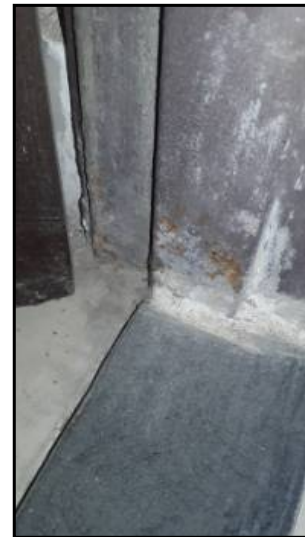
Surface rust noted on door frame

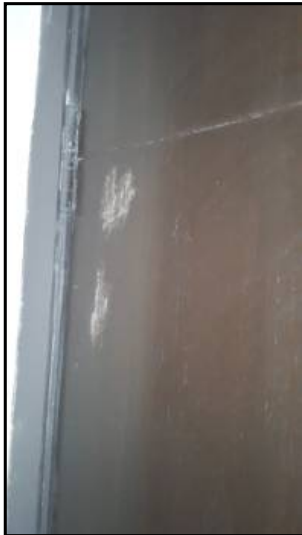
Paint deterioration noted on panel laminate

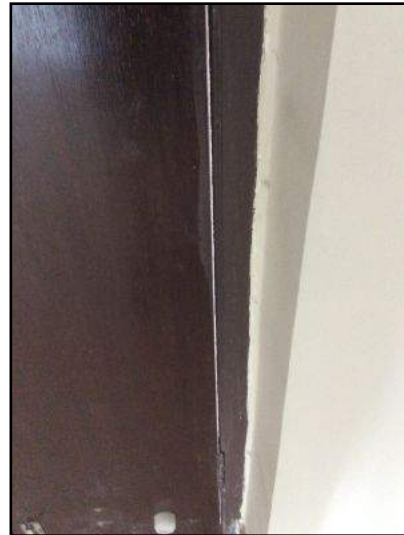
Gap between smaller panel and frame on closing

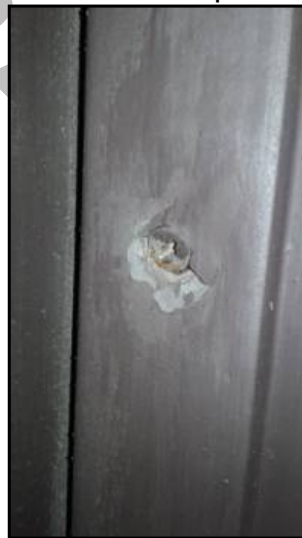
Fastener holes not filled

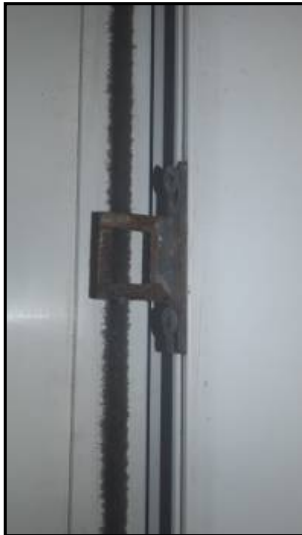
Surface rust noted on lock keeper plate

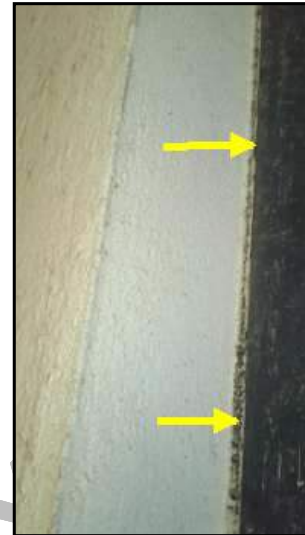
External gap noted around window

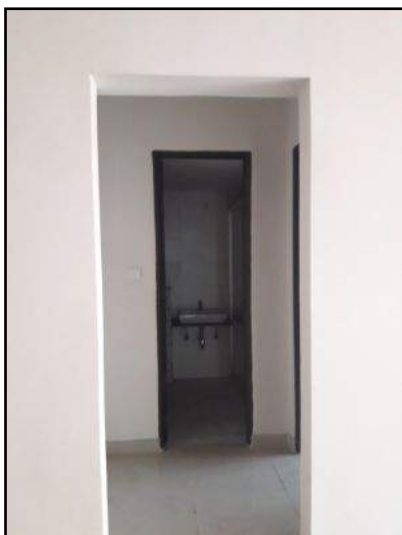
Reference picture of left alley

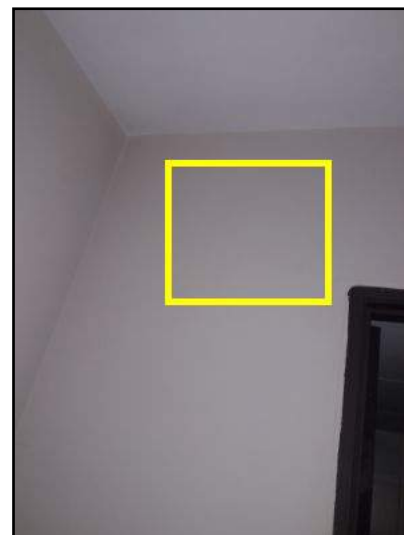
Hollow plaster noted on upper portion of front wall

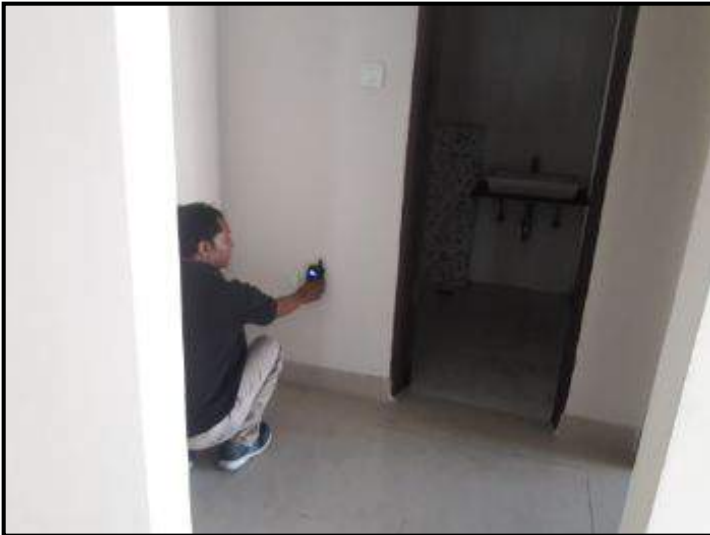
High moisture content on lower portion of front wall to the left side of bathroom 3 door

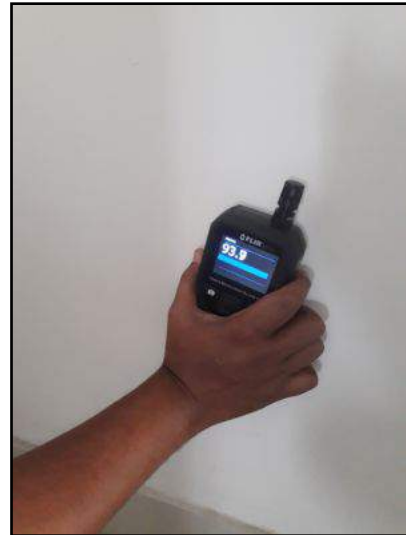
93.9 moisture content

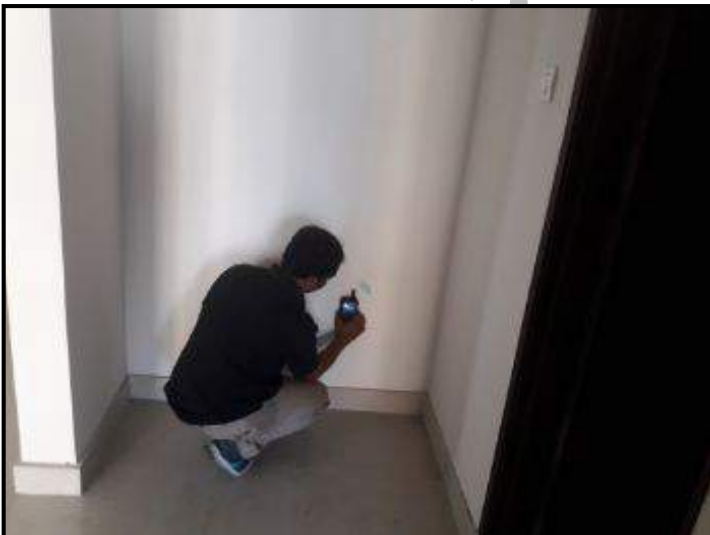
High moisture content on lower portion of left wall near corner with front wall

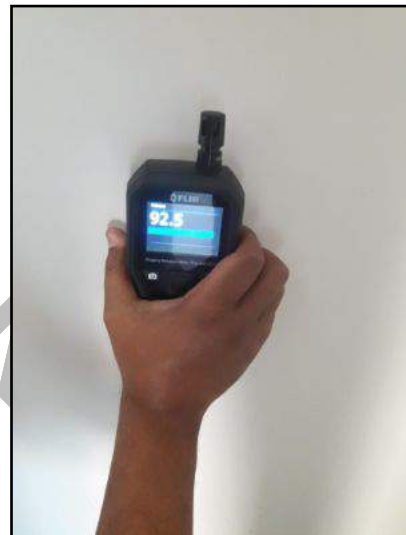
92.5 moisture content

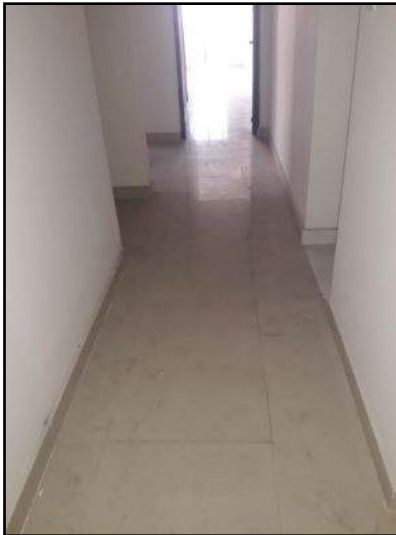
Reference picture of right alley

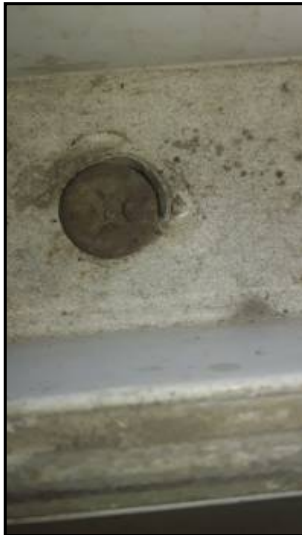
Rusted fastener on head jamb

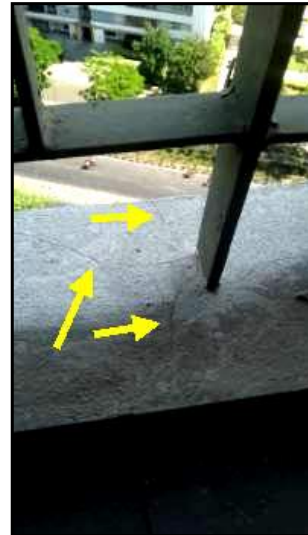
Multiple cracks noted on railing sill

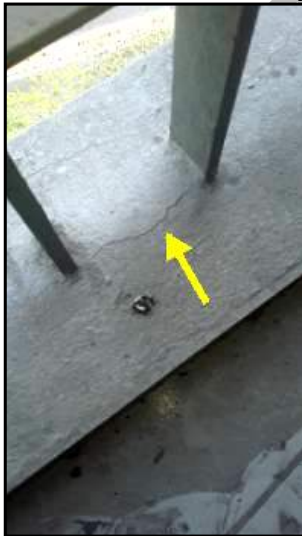
Crack noted on railing sill opposite to bedroom 3

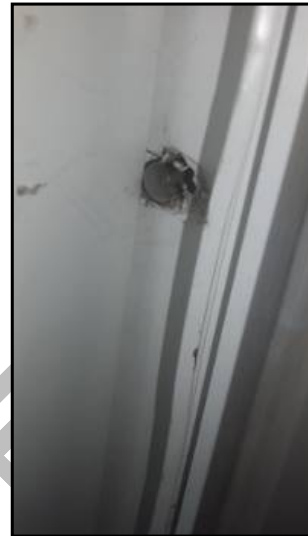
Fastener screw cap not installed

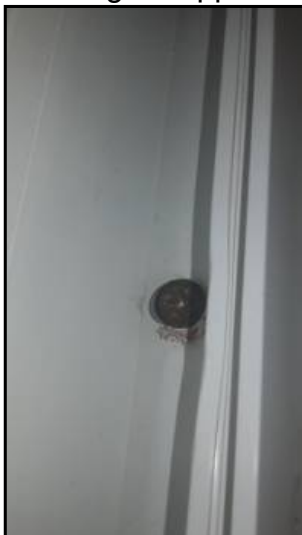
Fastener installation is improper

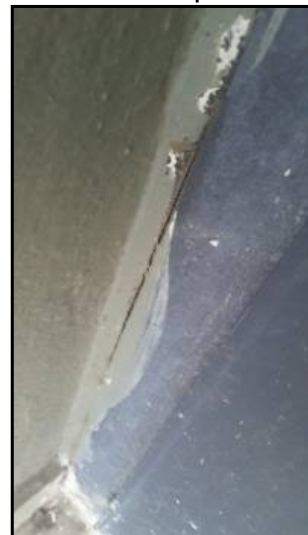
External gap noted between balcony door frame and wall

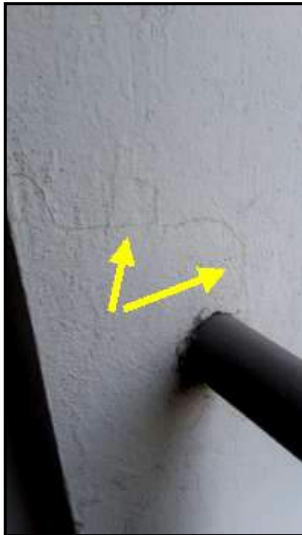
Significant diagonal crack noted on left wall near bedroom 4

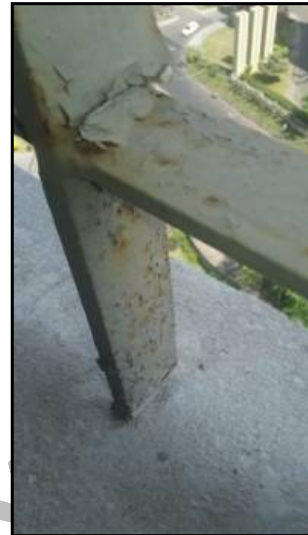
Paint peeling off and rust noted on MS rail

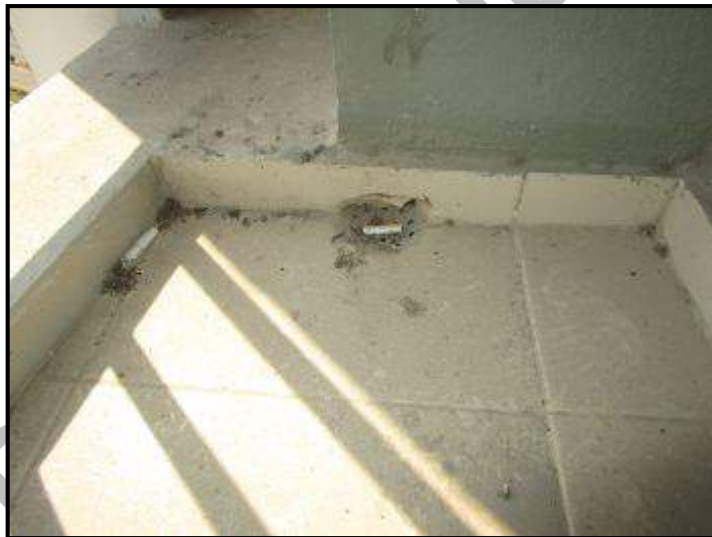
Right side grating near bedroom 3 is partially under the wall

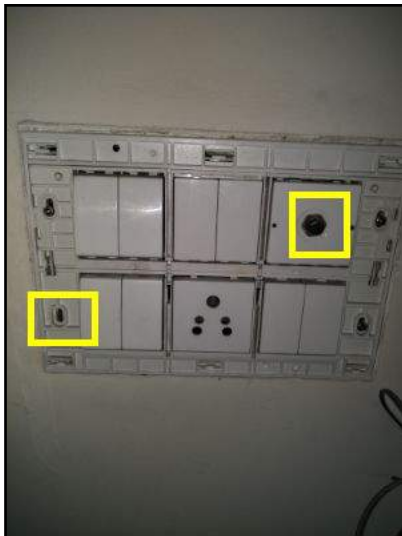
One screw and fan regulator not installed on light switch board

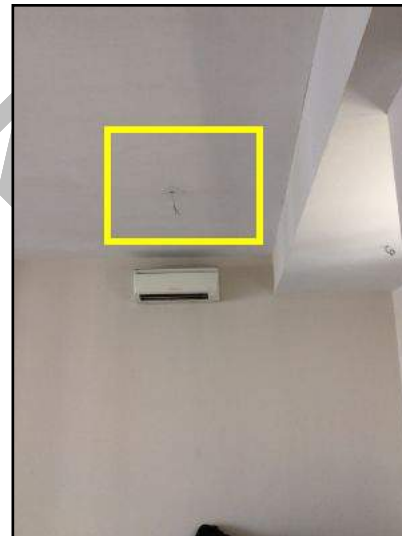
Improper position of fan box

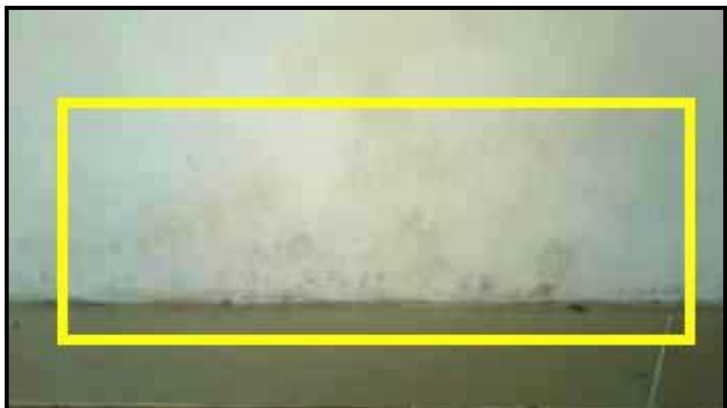
Moisture patches and paint pop up noted on lower portion of right wall

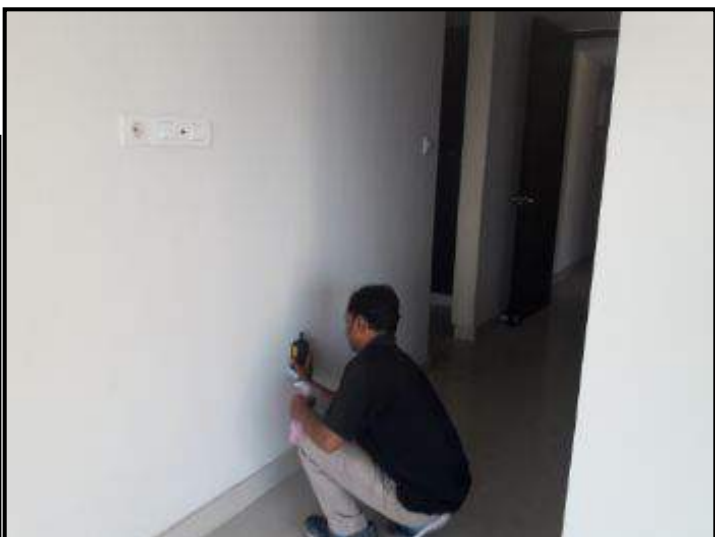
High moisture content on right wall lower portion near switch board

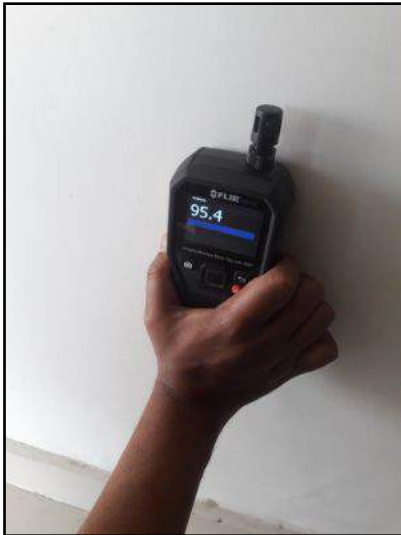
95.4 moisture content

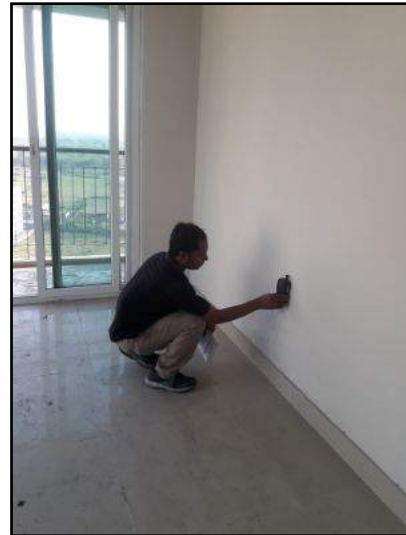
High moisture content on lower portion of right wall below AC

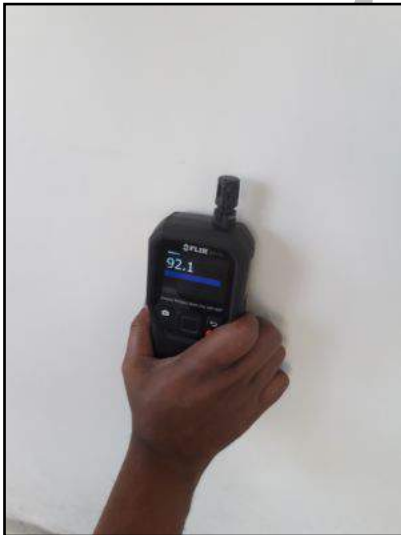
92.1 moisture content

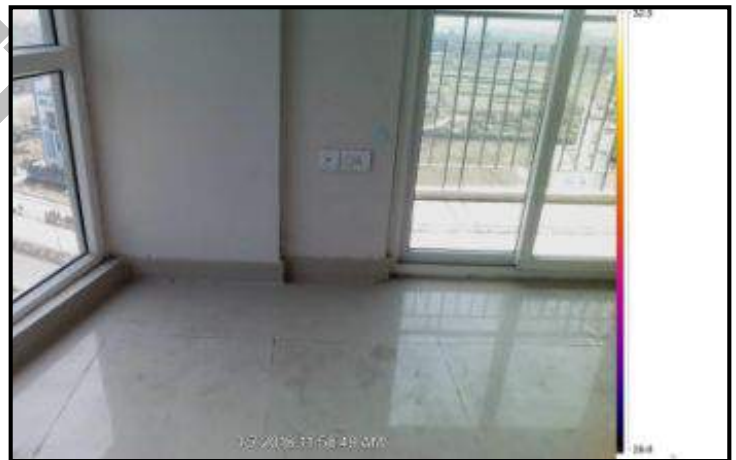
Visual Image of Bedroom 1 front wall

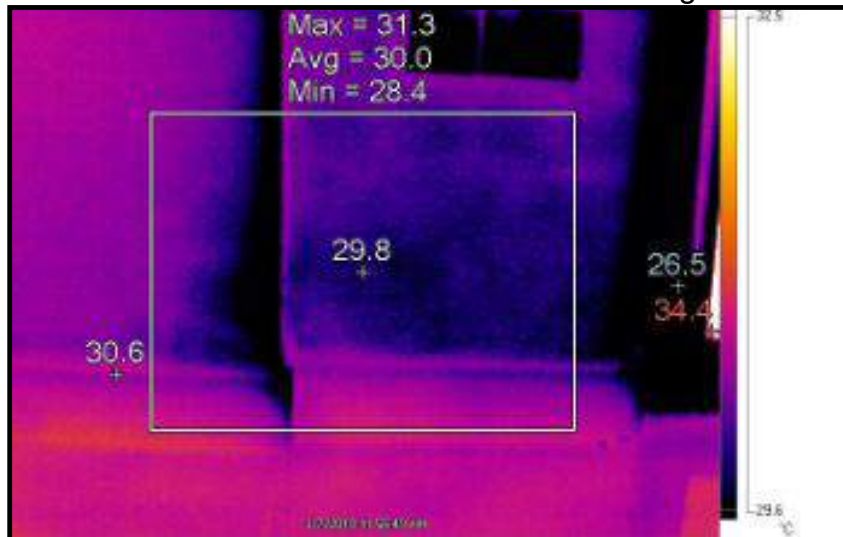
Infrared image showing moisture intrusion

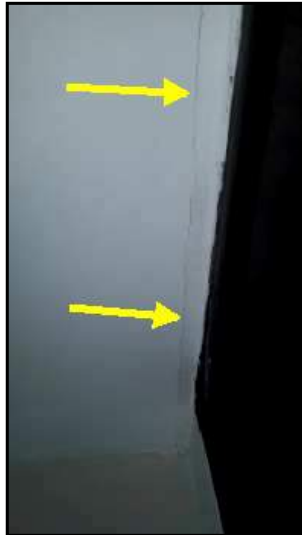
False ceiling board joints visible

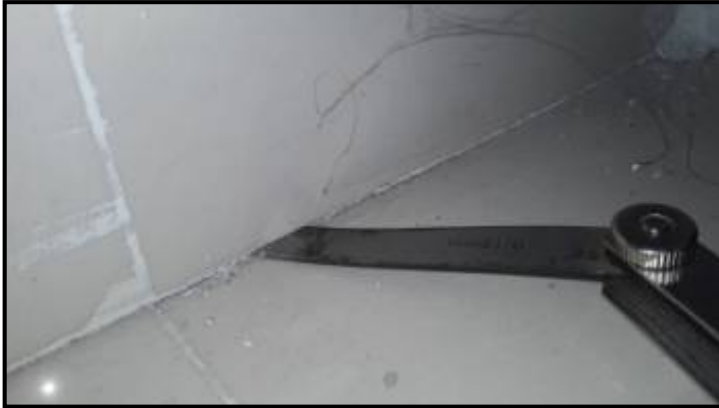
Gap noted at junction of right wall skirting and floor tile near entrance door

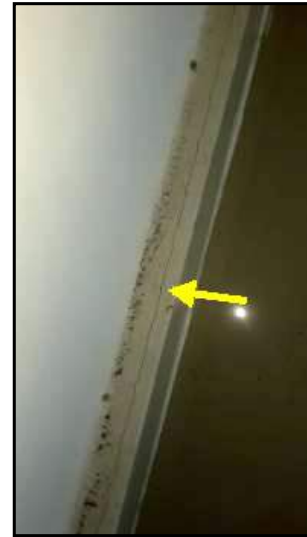
Crack noted at junction of back wall and skirting

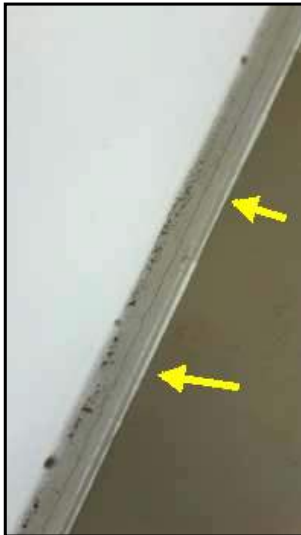
Hollow back wall skirting noted near corner with left wall

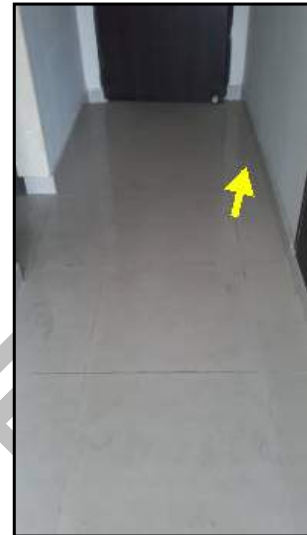
Entrance passage : All tiles except the marked one are hollow

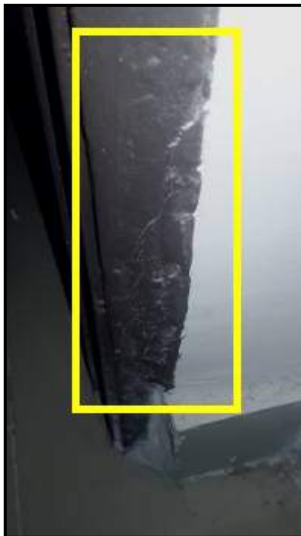
Uneven surface finish noted on inside lower portion of right jamb

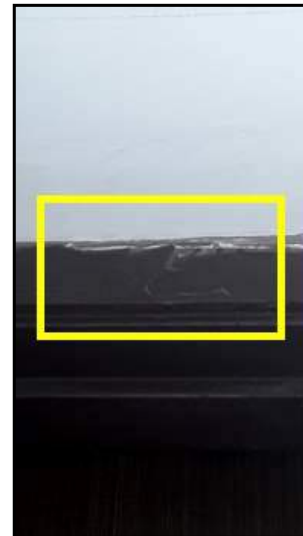
Paint peeling off noted on head jamb

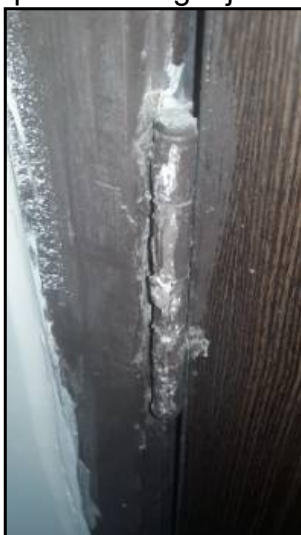
Paint deterioration noted on door hinge

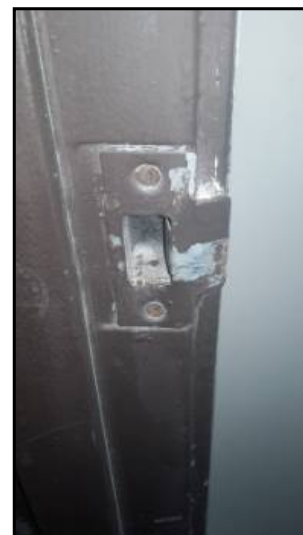
Rusted screw noted on groove plate

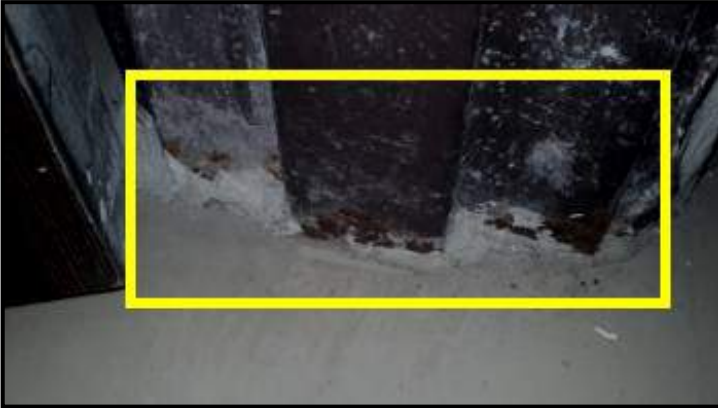
Surface rust noted on lower portion of right jamb

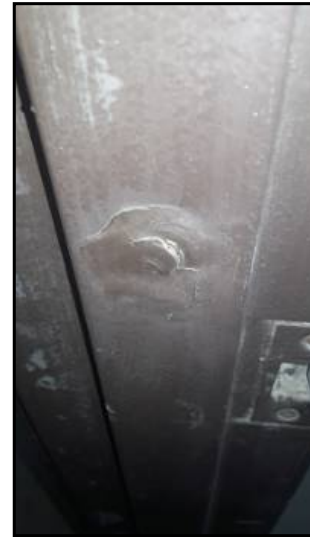
Fastener not concealed within door frame

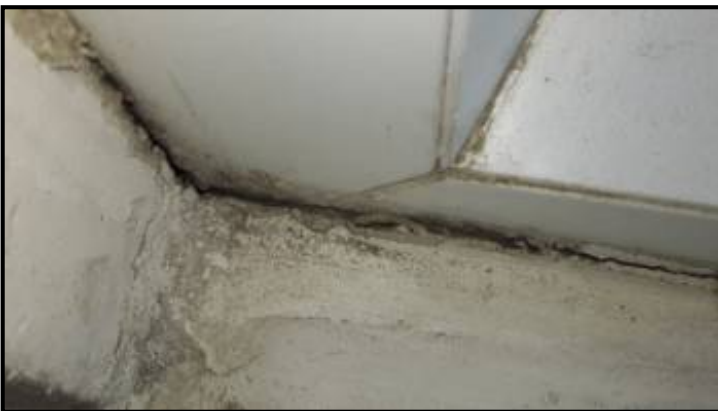
Gap noted at junction of window frame and wall on inside

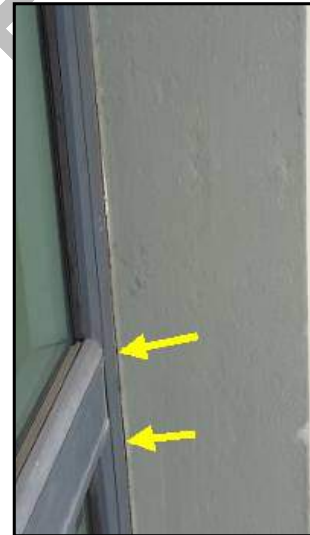
External gap noted around window frame

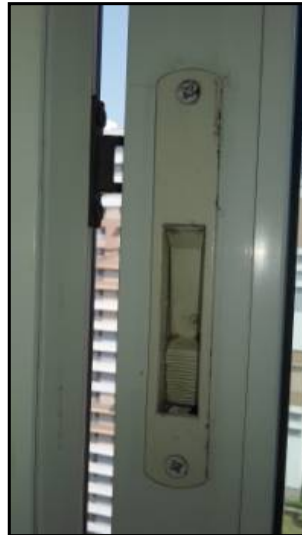
Left side panel lock not working

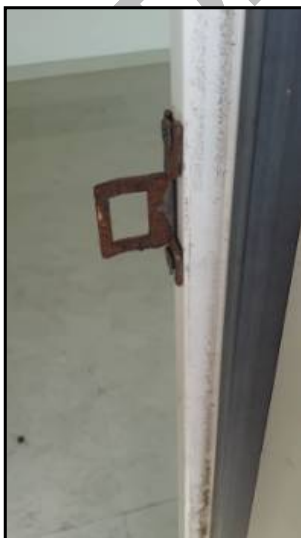
The keeper is protruding out of the door edge

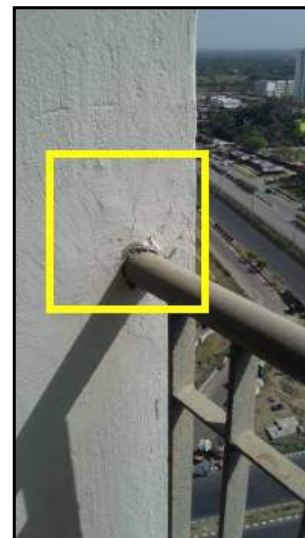
Crack and hollow plaster noted around ms rail fixation with wall

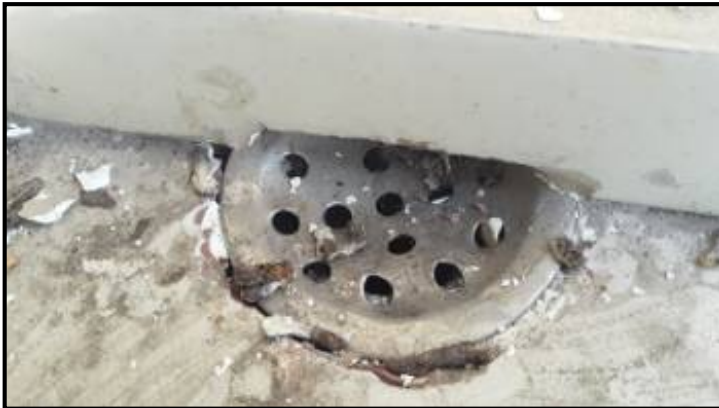
Grating partially under the wall and grouting not done

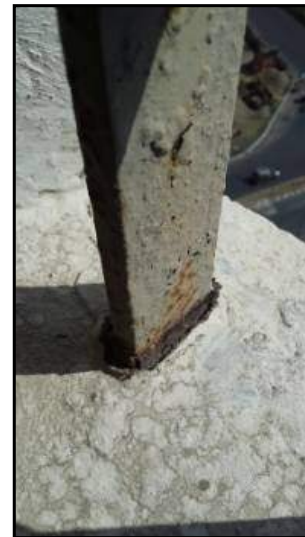
Surface rust noted on MS rail

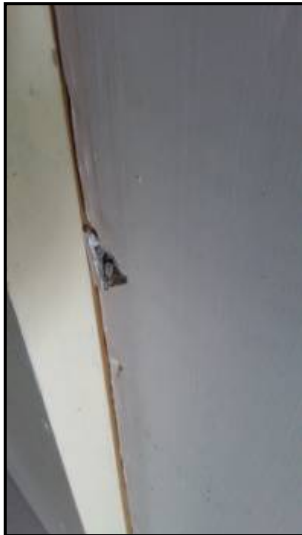
Broken false ceiling board noted near entrance

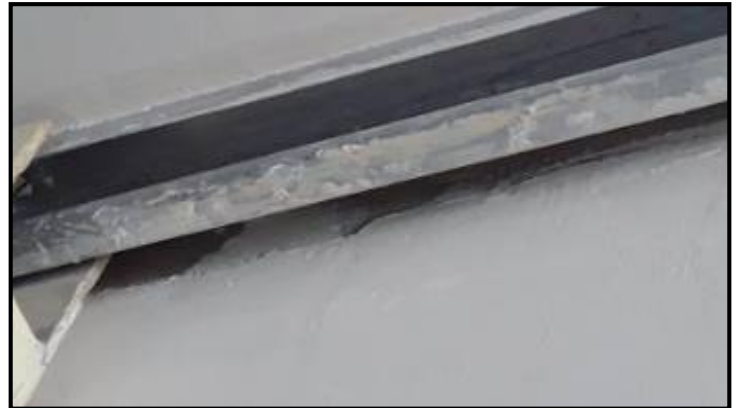
Primer finish not done near top channel of sliding door

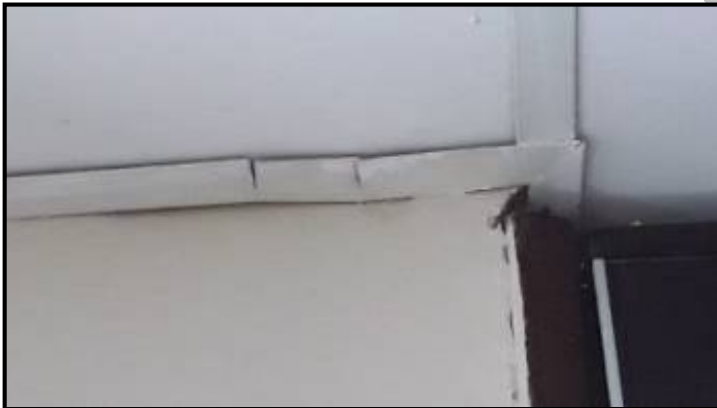
Damaged aluminium channel noted near front wall

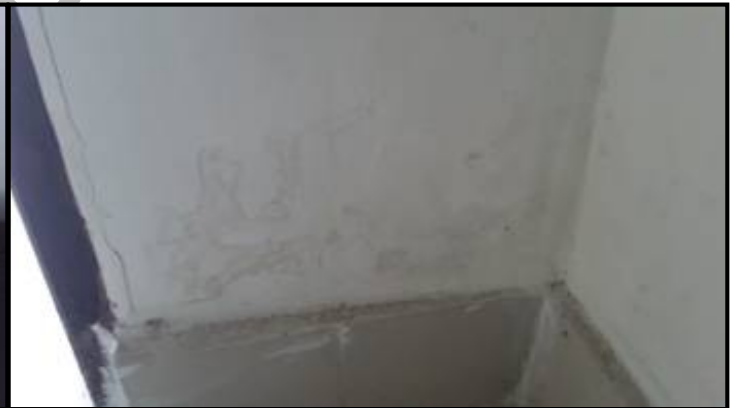
Moisture patches and paint deterioration noted on lower portion of left wall

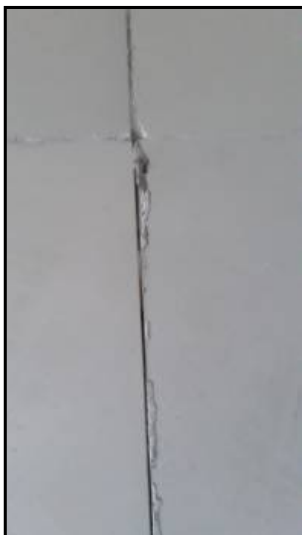
Joint filling not done on floor tile joints near right side corner of front wall

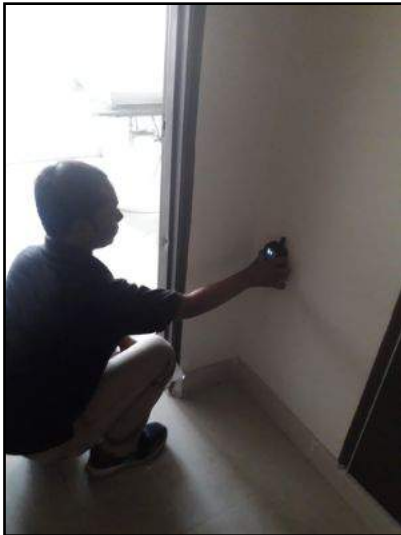
High moisture content on front wall

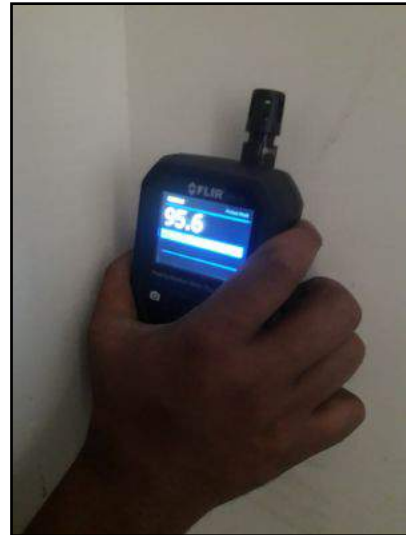
95.6 moisture content

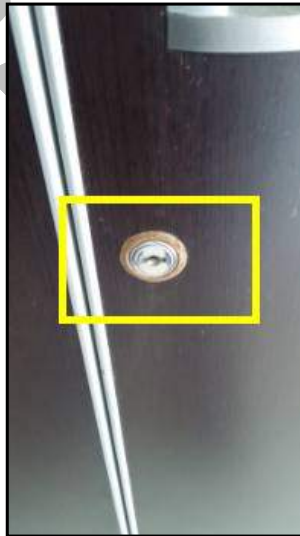
Surface rust noted on lock hardware of cupboards

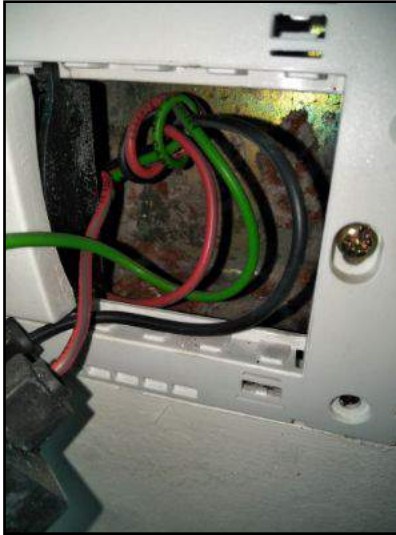
Improper wiring noted inside light switch board

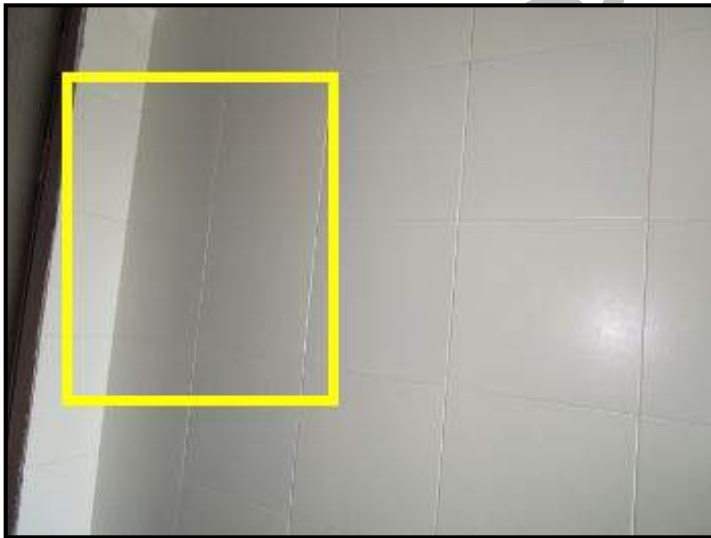
Tiles of different shades installed

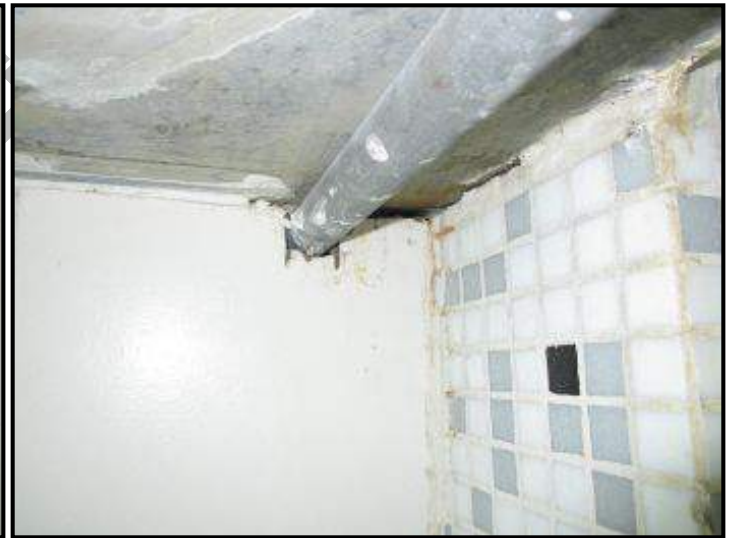
Gap noted around counter support

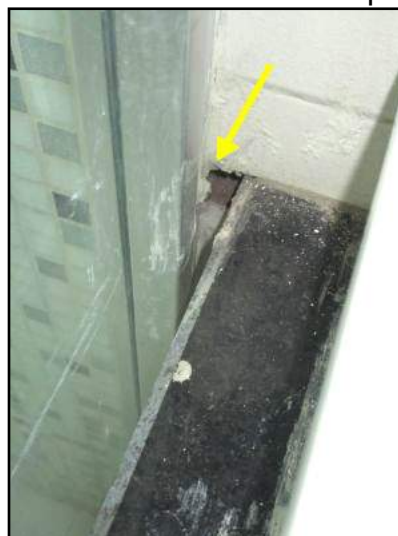
Unfilled gap noted on left side of sink counter

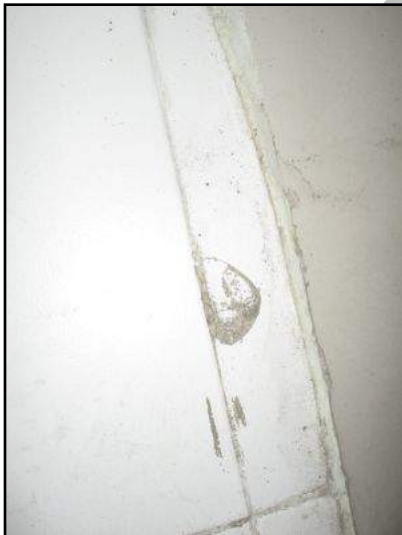
Damaged floor tile noted near entrance

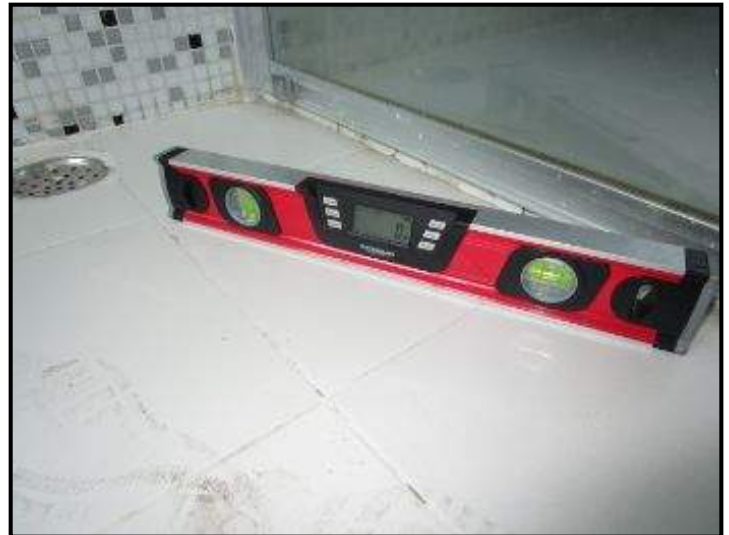
Water pockets noted in shower area around near shower area sliding door

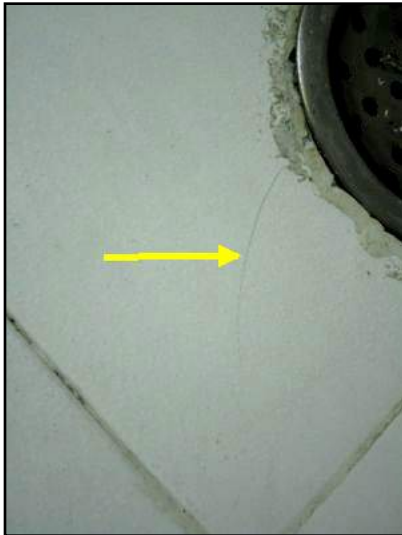
Crack on floor tile near shower area grating

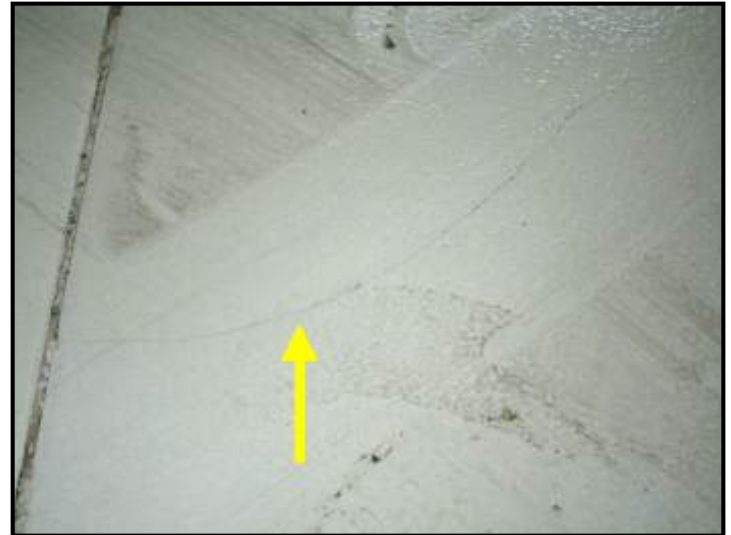
Crack noted on floor tile at middle portion near basin counter

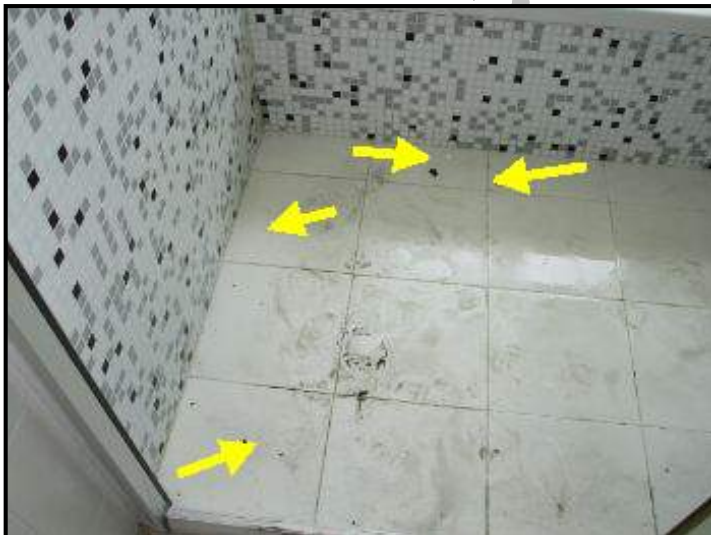
4 nos hollow tiles noted in shower area

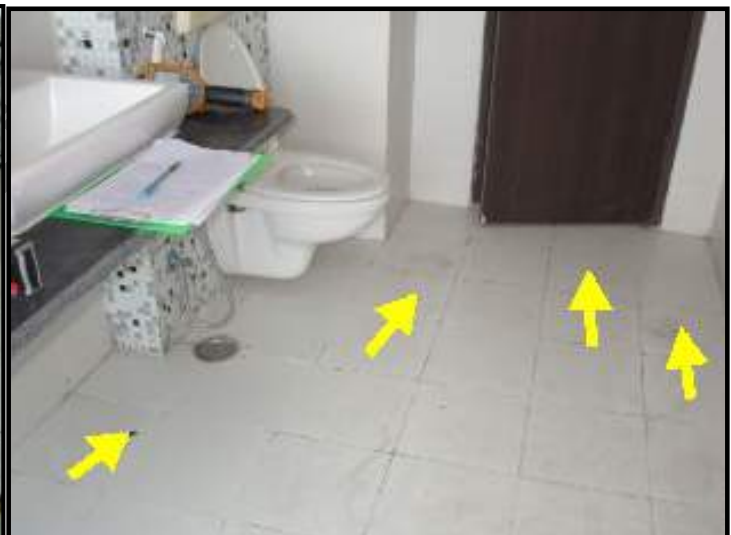
4 nos hollow tiles noted in WC area

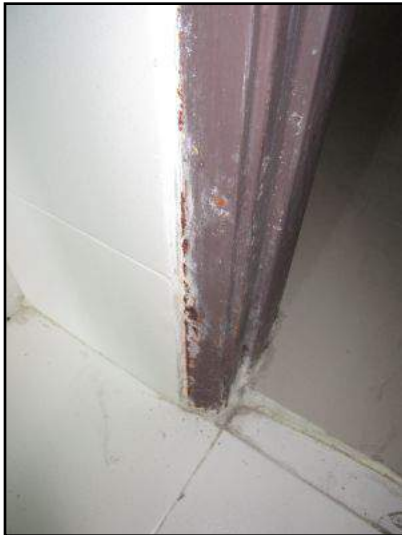
Surface rust noted on door frame

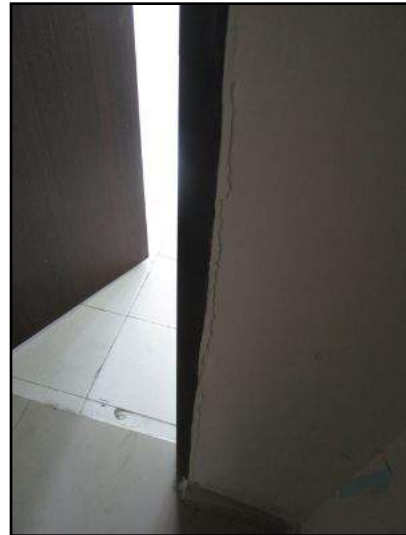
Crack running along the frame and wall
