# *A Buyer's Choice Home Inspections*

## Property Inspection Report

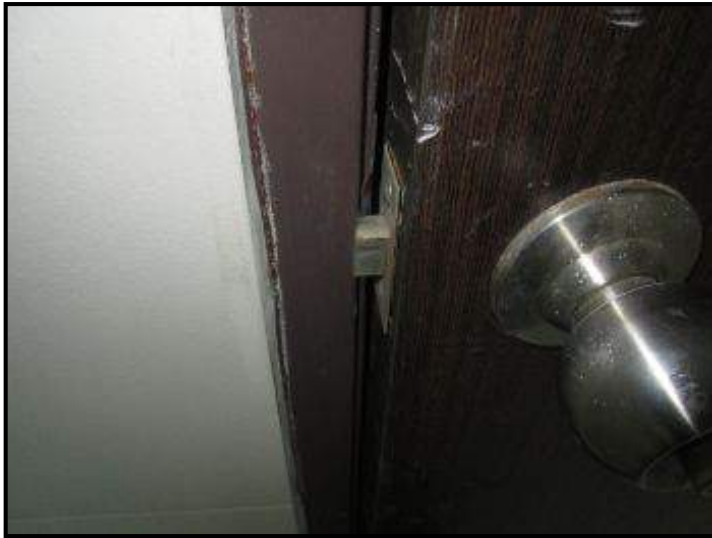
Door panel not locking

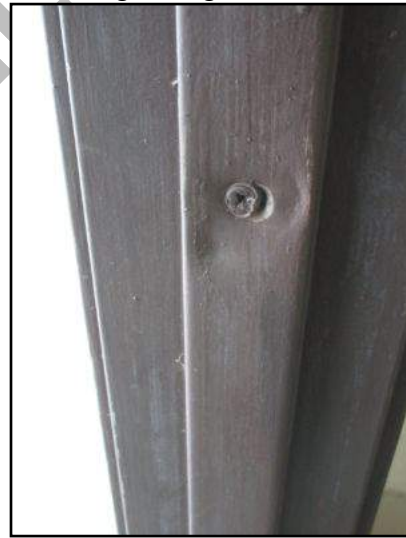
Fasteners visible on door frame

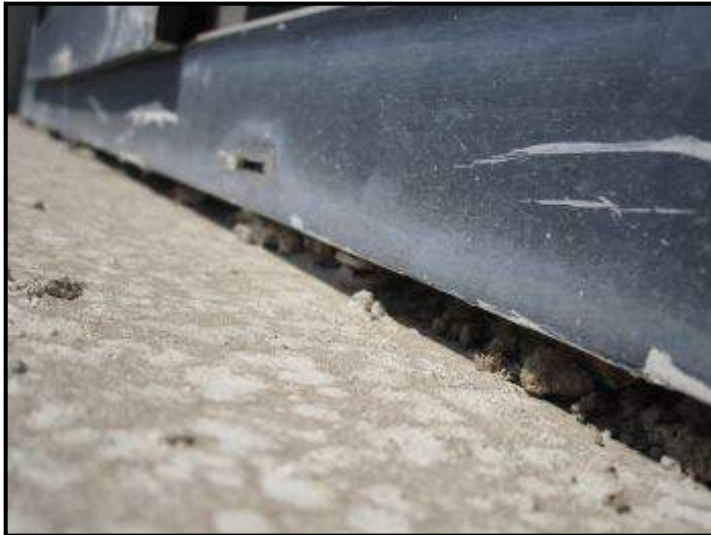
External gap around window frame

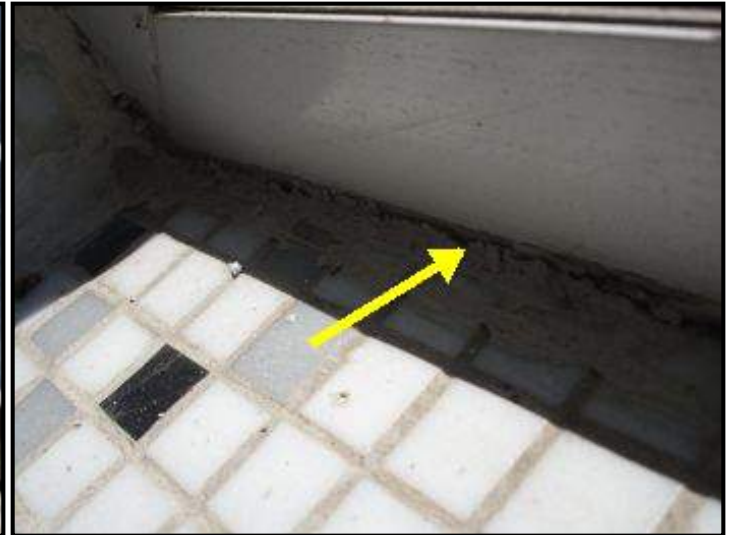
Non uniform putty filling noted at junction of window frame and wall tiles

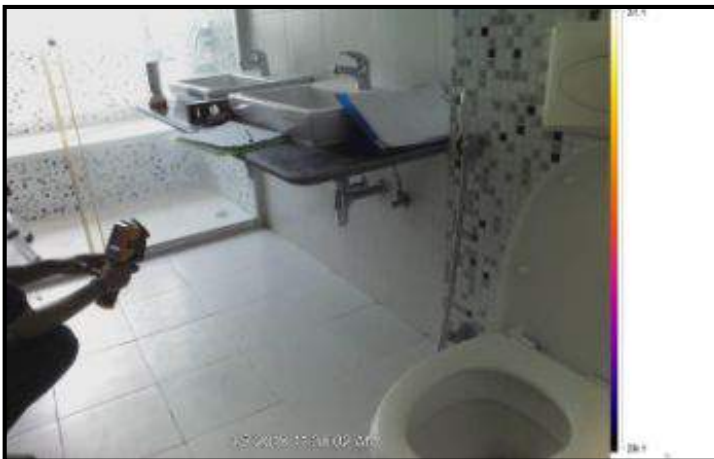
- Leakage and water dripping from the outlets of both the sinks more at the right side sink.
- We recommend the bottle trap to be checked for blockage and internal leakage. If not then re-installed into PVC conceal outlet with suitable sealant or gasket.

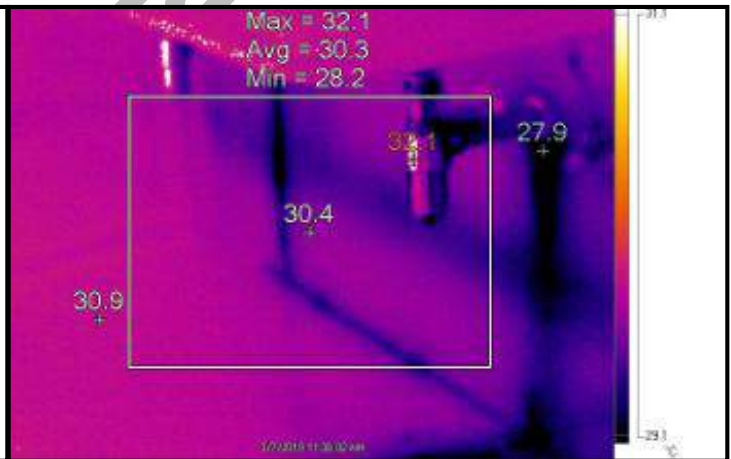
Leakage at outlets of both the sinks

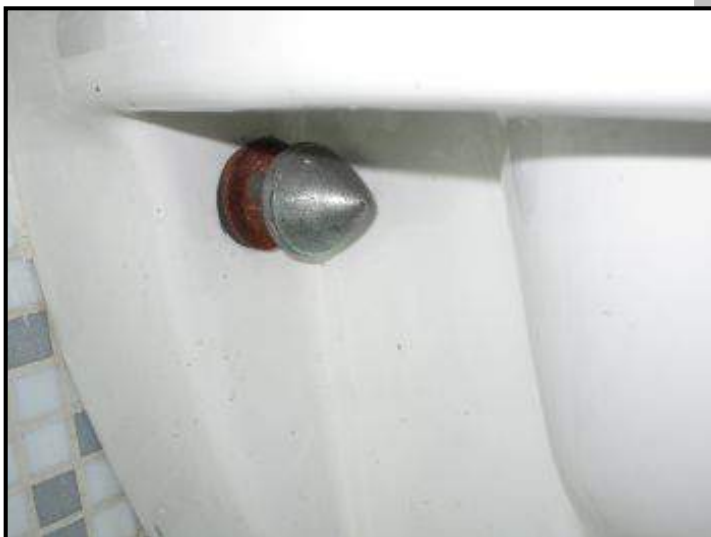
Rusted washer noted on WC

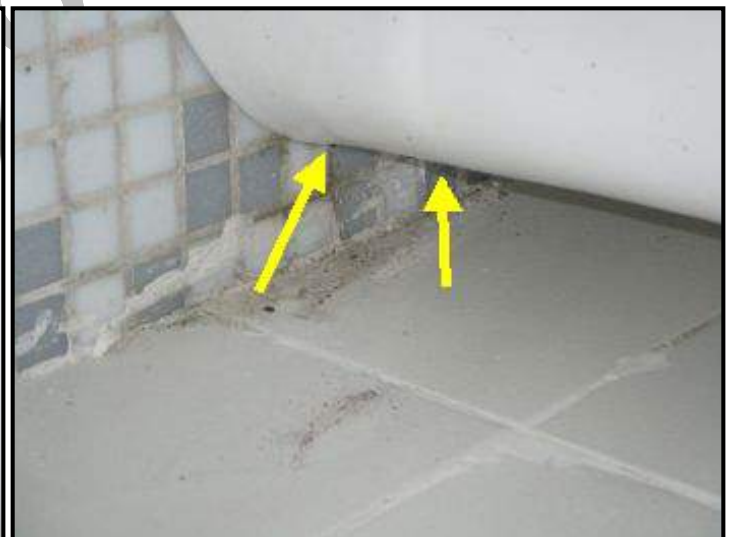
Visible patches at WC bottom due to leakage

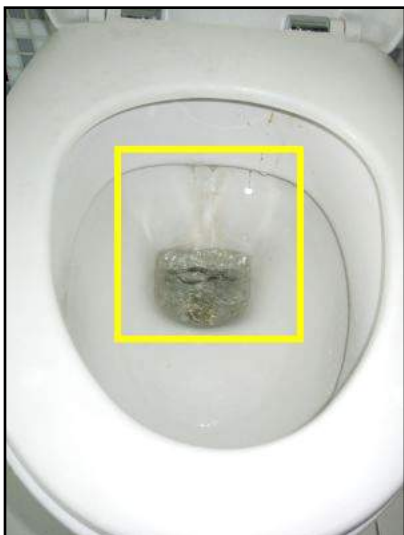
Continuous flow of water at the WC

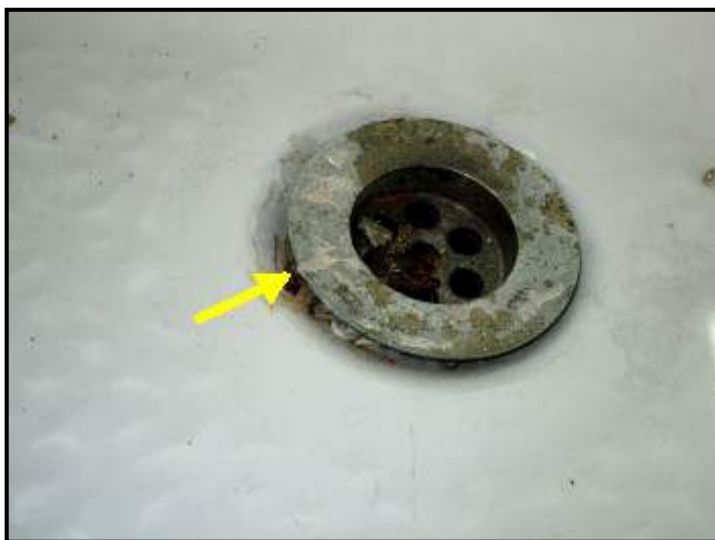
Gap noted around bathtub waste

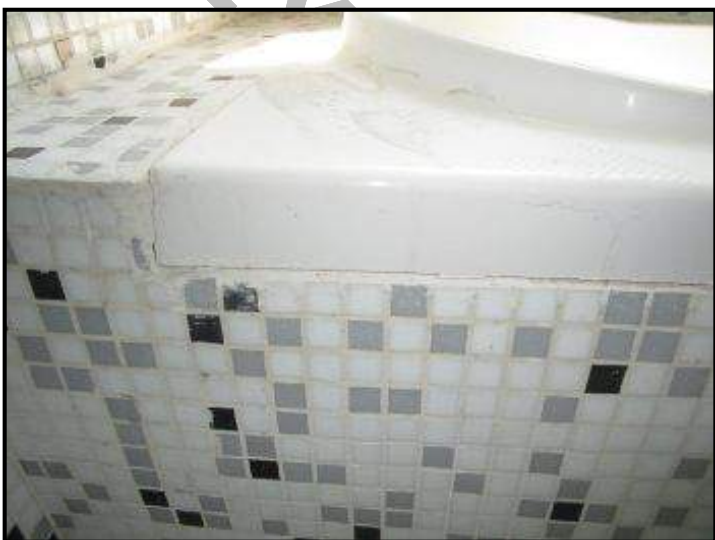
Gap between bathtub and walls around

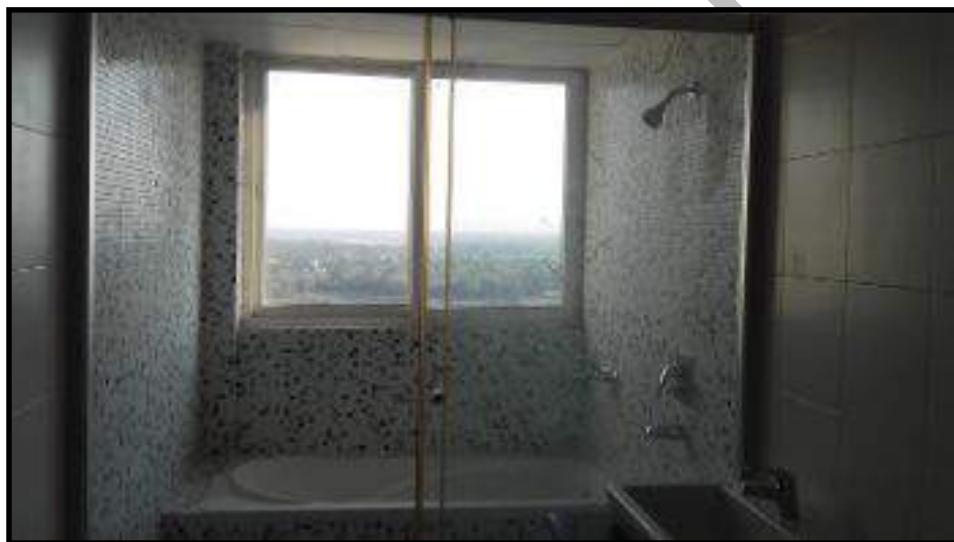
Provision for exhaust not provided

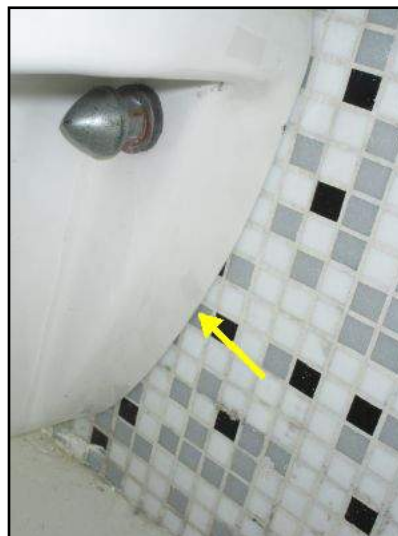
Gap between WC and wall

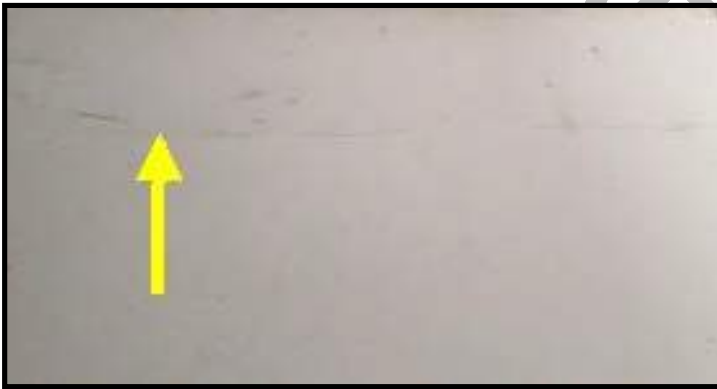
Crack noted on back wall upper portion

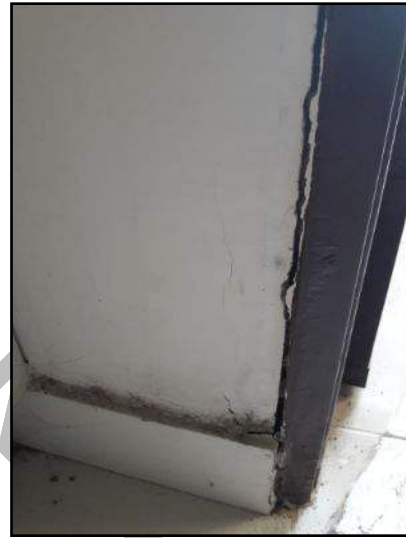
Distinct crack along the wall and door frame

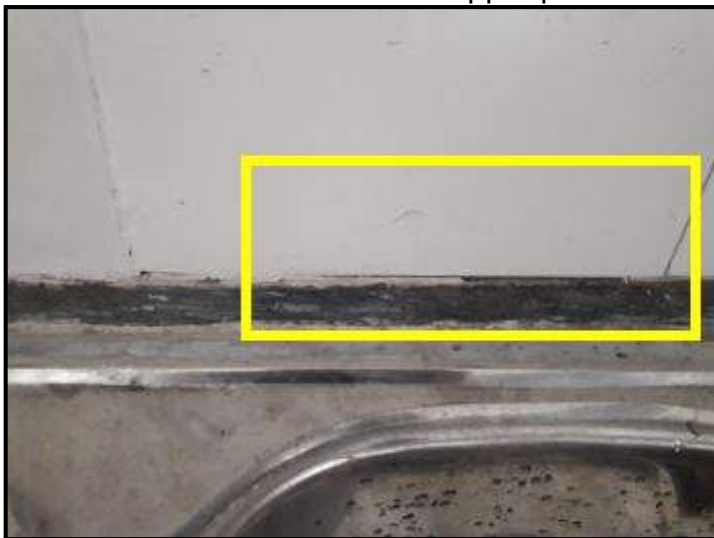
Gap noted between dado tile and counter

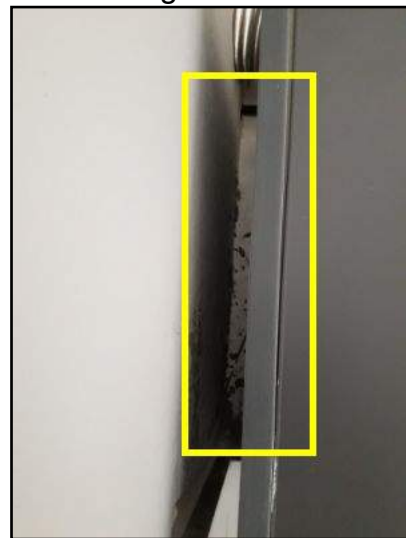
Improper putty finish noted on wall surface behind the cabinet

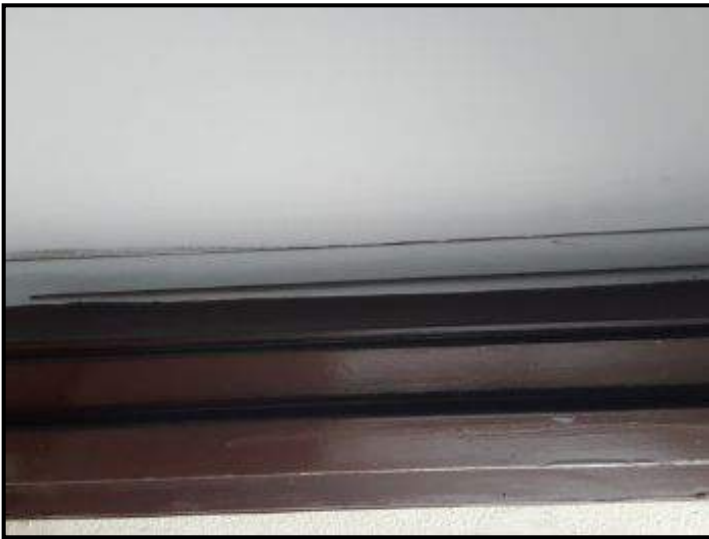
Gap between false ceiling and wall surface above kitchen balcony door frame

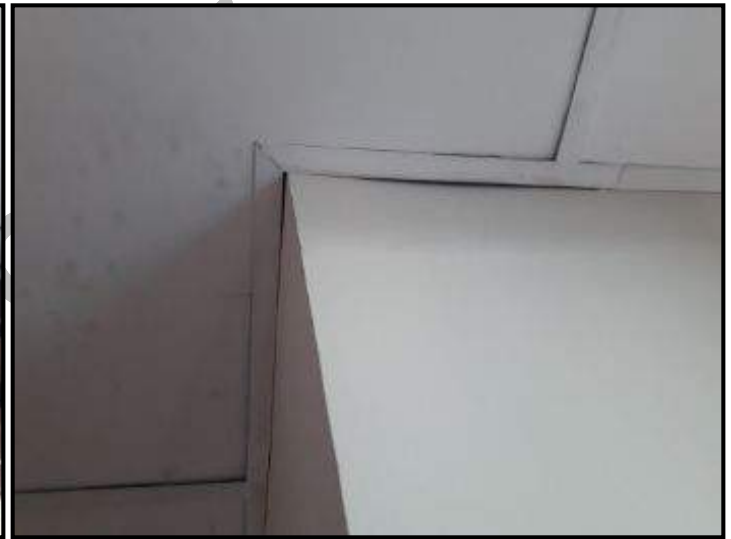
Uneven gap noted at junction of false ceiling and wall surface

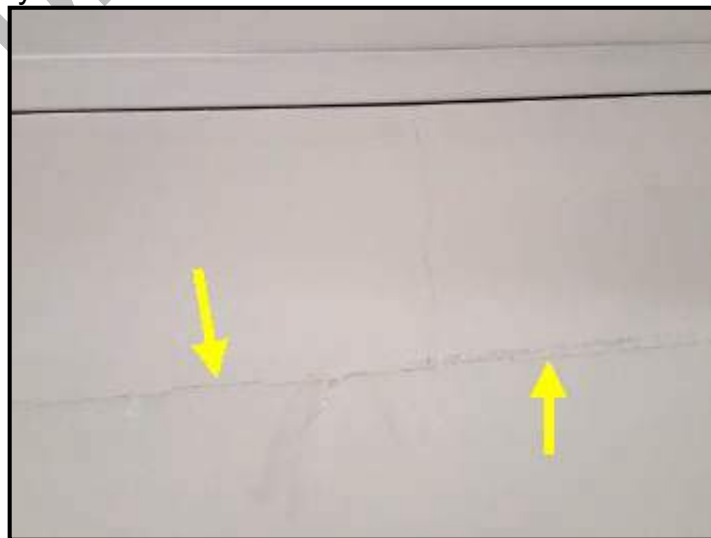
Crack noted at junction of alley false ceiling and kitchen false ceiling

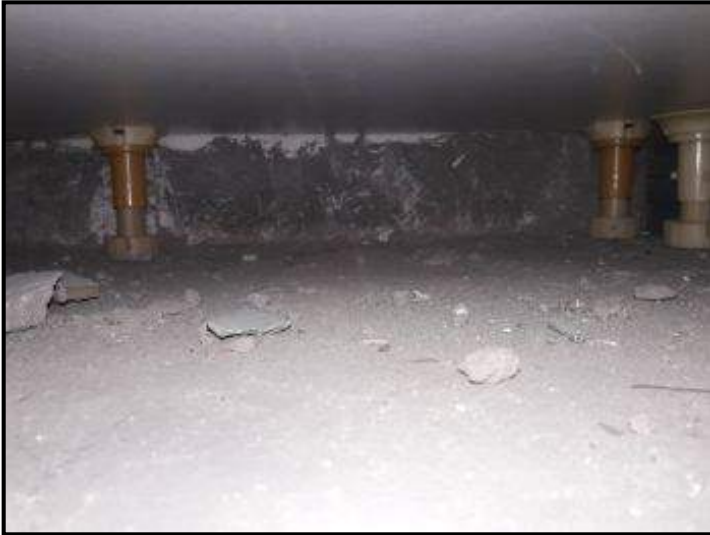
Skirting not provided behind the cabinet

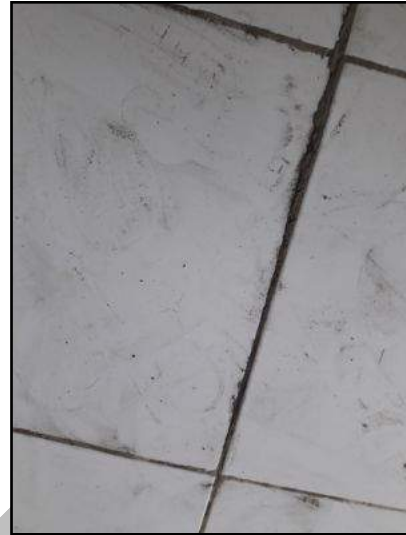
Inadequate tile joint filling noted at places

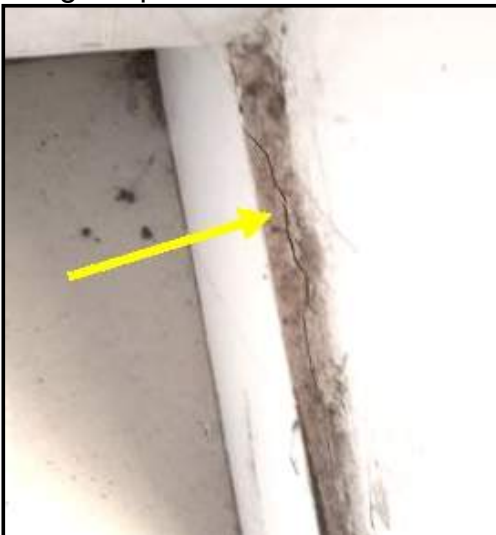
Detachment of skirting from left wall noted near balcony door

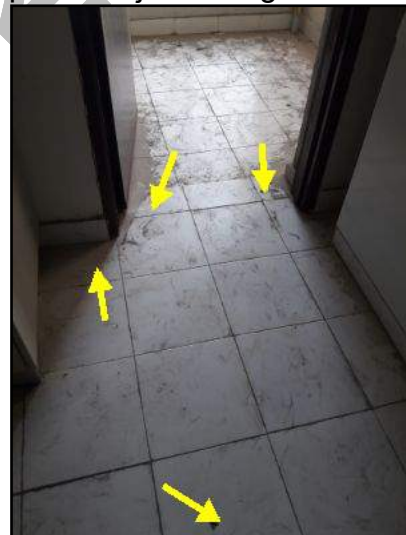
4 hollow tiles noted near balcony door

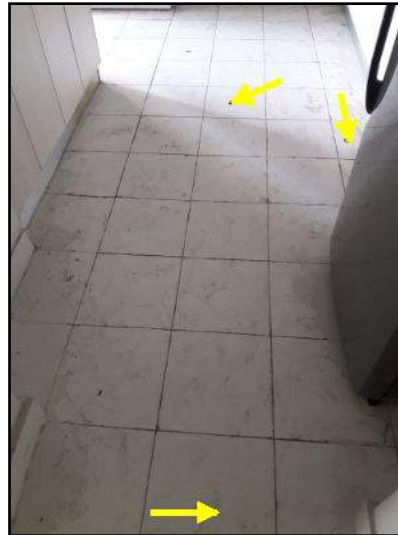
3 hollow tiles noted near fridge

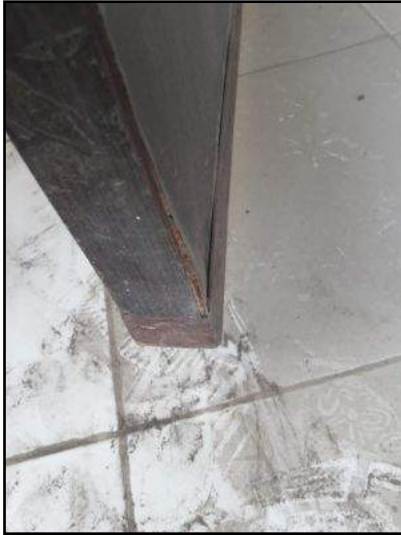
Segregation noted on back side of laminate near bottom portion of locking edge

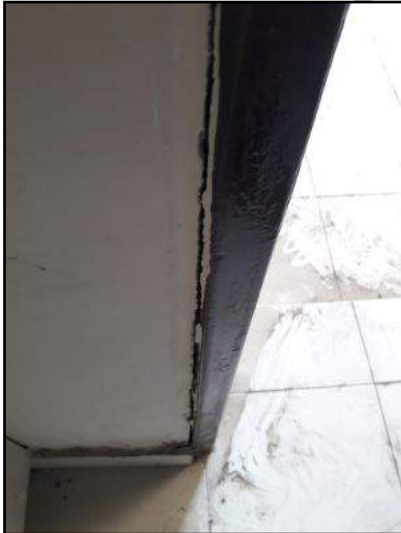
Unstable door frame due to crack at junction of left jamb and wall

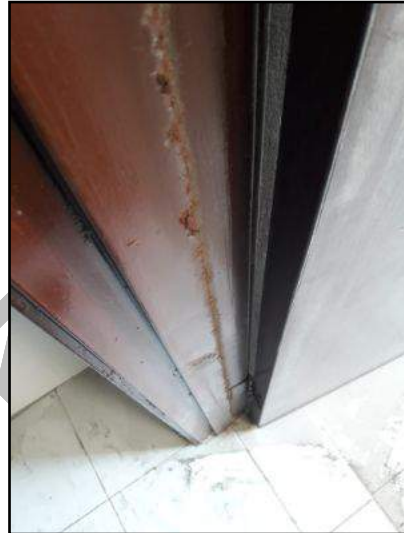
Rust noted on door frame

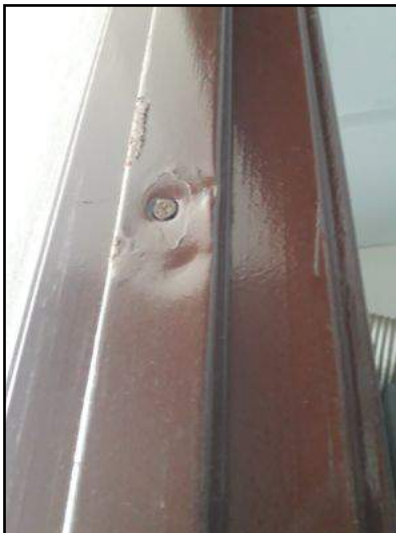
Fasteners not concealed within frame

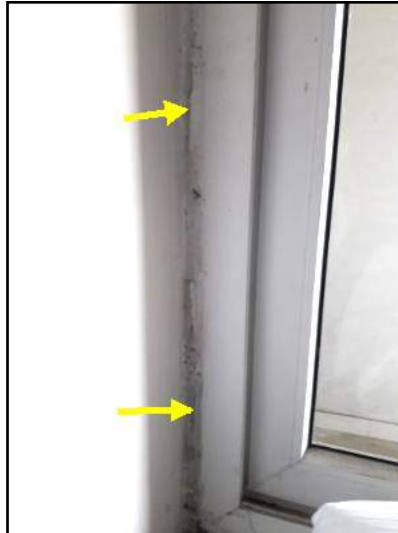
Inadequate application of filler

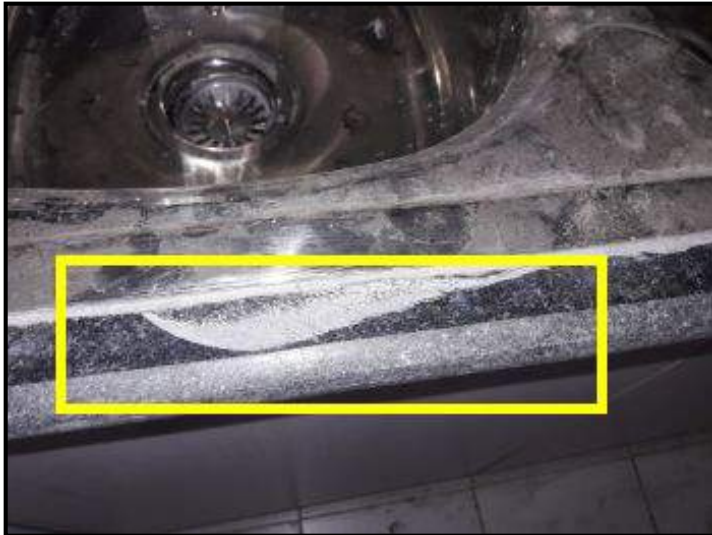
Grinding not done on counter top near sink

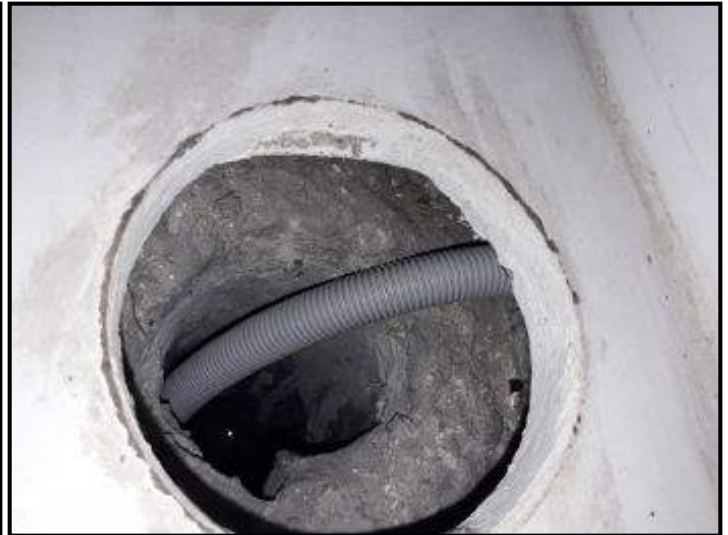
Cement heap noted around floor drain outlet

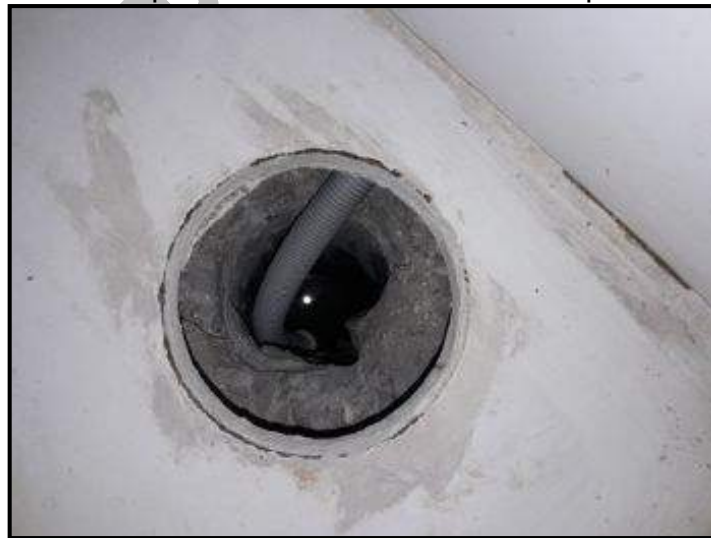
Grating not provided at outlet

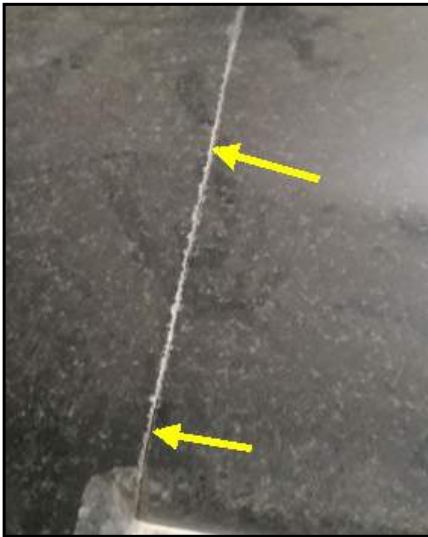
Inadequate joint filling noted on counter top

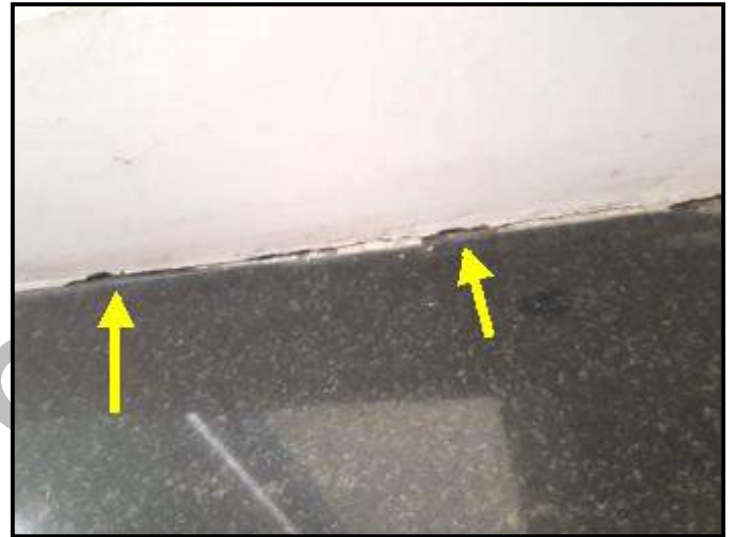
Left side counter top loosely fitted and distinct gap with wall

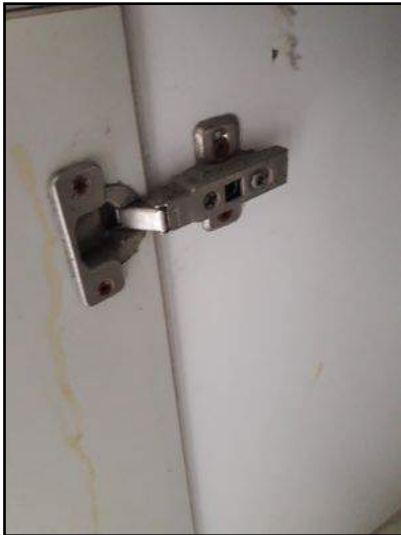
Rusted cabinet panel hinges

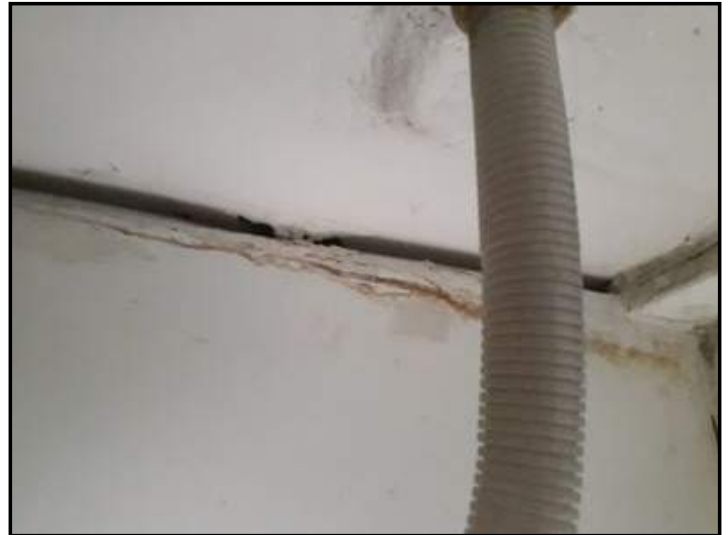
Sink counter cabinet : Rear side head plank is damaged due to water infiltration

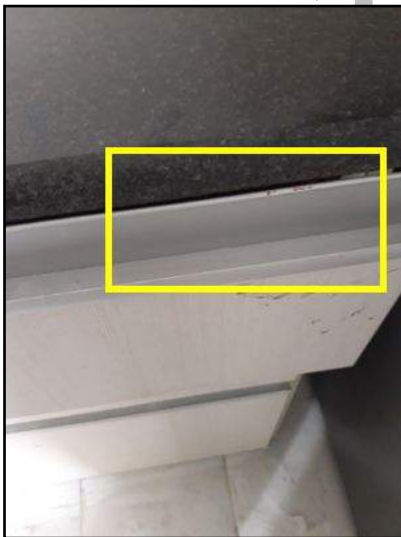
Top drawer aluminium channel operating handle is flashing with counter top

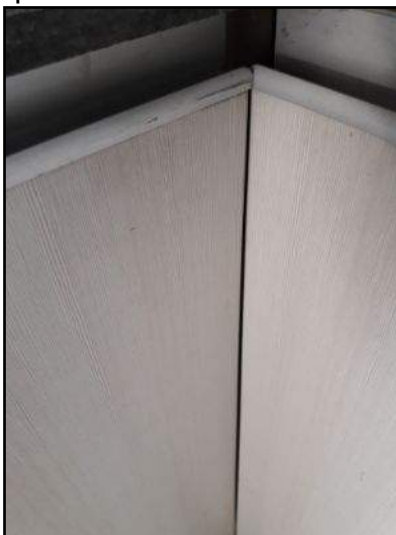
Right side counter cabinet : Last panel is not opening

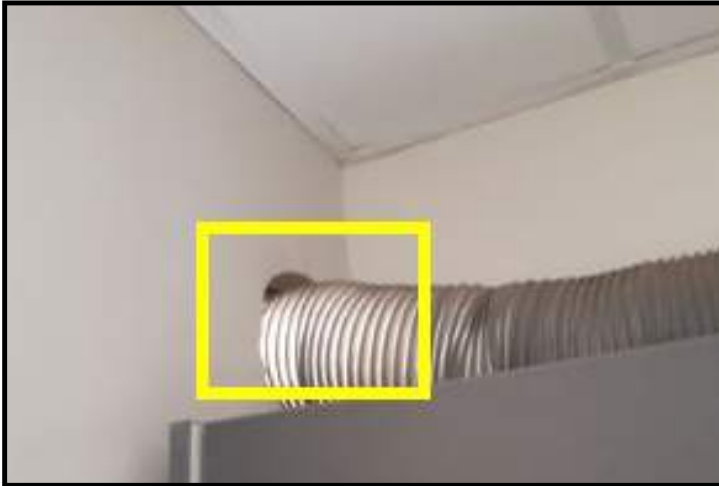
Gap around chimney vent sleeve

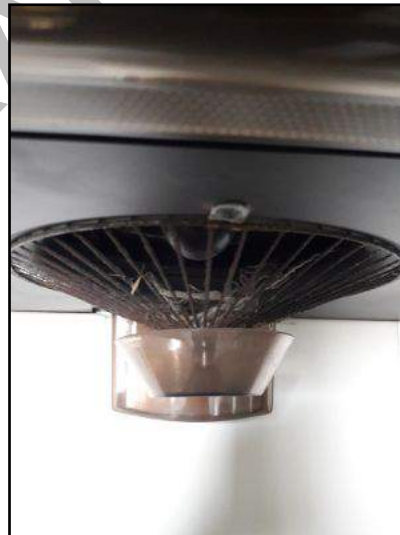
Exhaust grill rusted

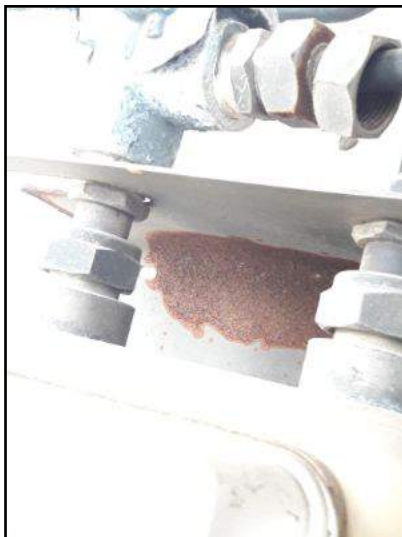
LPG meter plate rusted

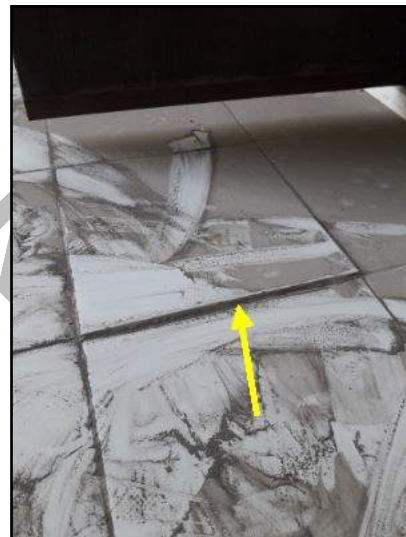
Layout of floor tiles is uneven near entrance

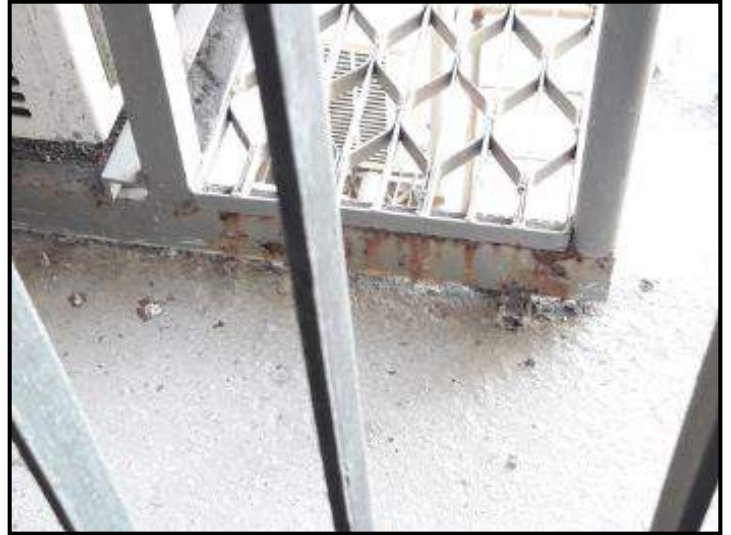
All tiles except the marked ones are hollow

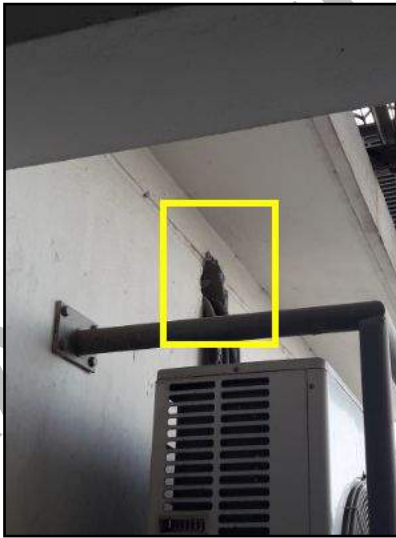
Packing not done on external wall around AC pipe sleeve

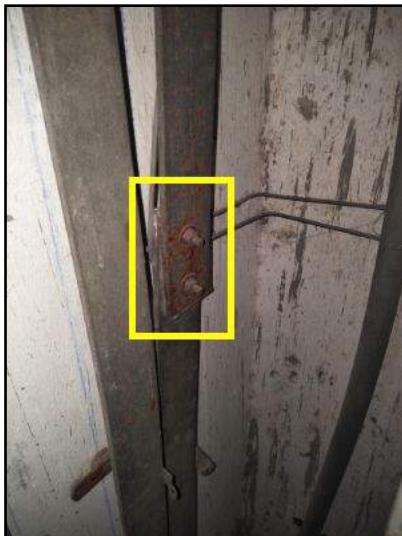
Welding not done at earthing plate joints

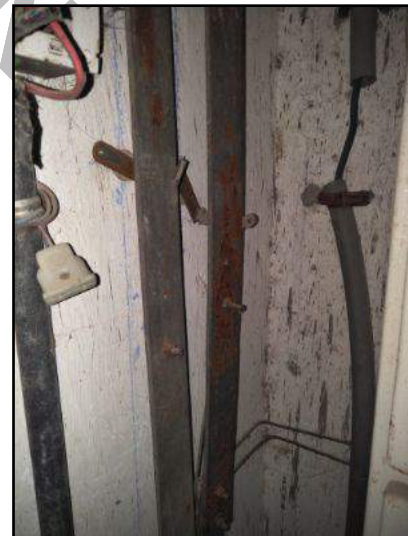
Rust noted on earthing plates

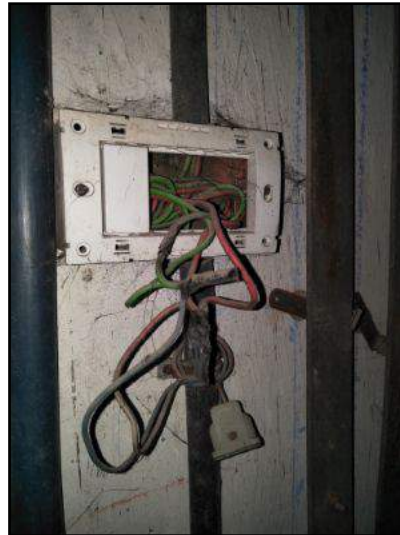
Switch and socket not installed in socket board

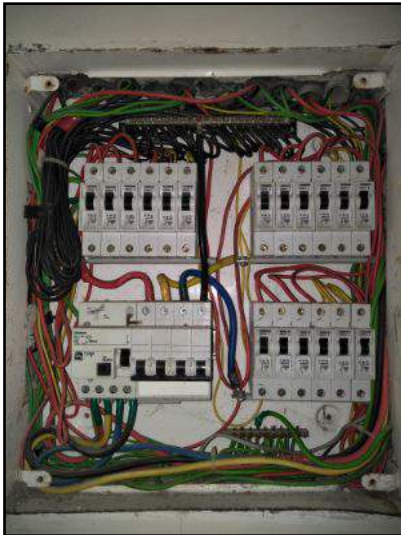
Complete Distribution Panel

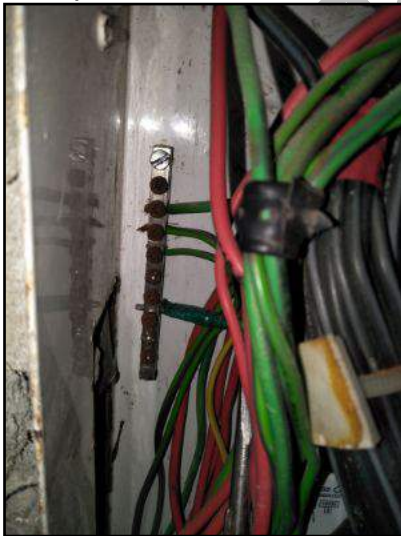
Earthing bar screws rusted

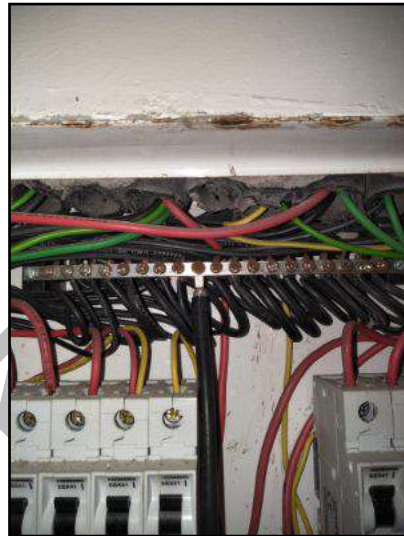
Neutral bar screws rusted

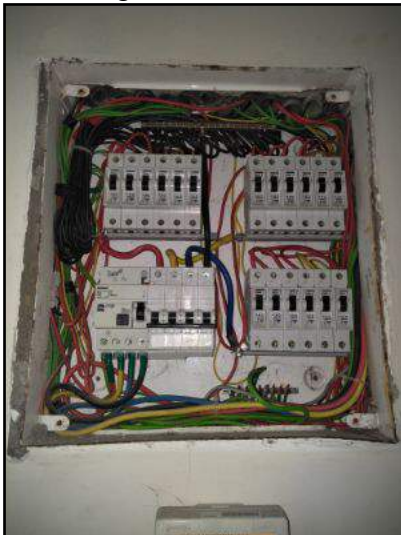
Wire dressing not done properly inside DB

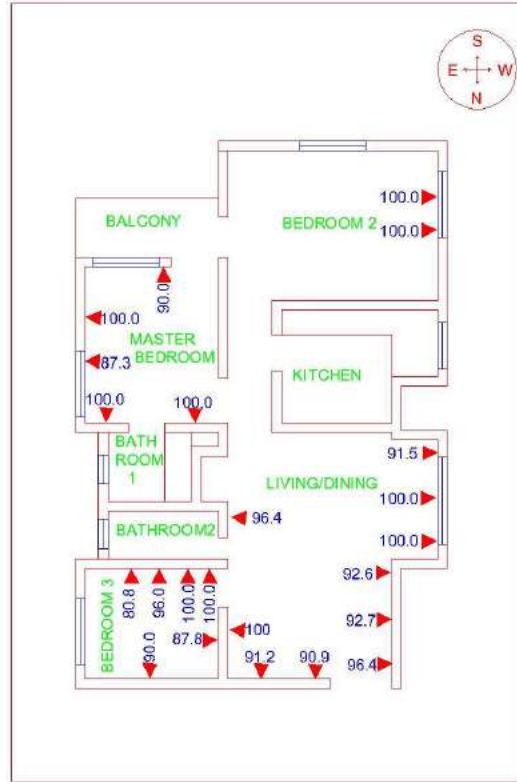
### ANNEXURE - 3 MOISTURE MAPPING
