MACJ - A Buyer's Choice Home Inspections

Property Inspection Report

Unit XYZ, EM Bypass, Kolkata, West Bengal 700054

A 4BHK apartment in a multi- building complex in east Kolkata region

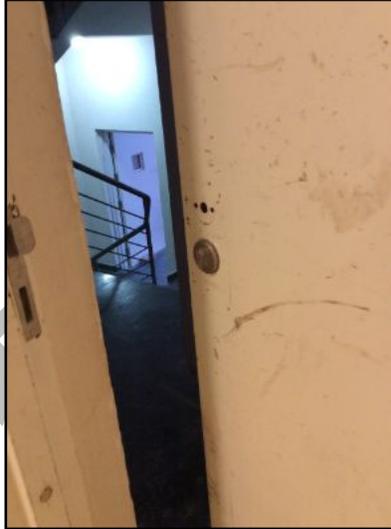
- The fire exit door handle is broken, recommend to maintenance to be repaired.

Broken handle

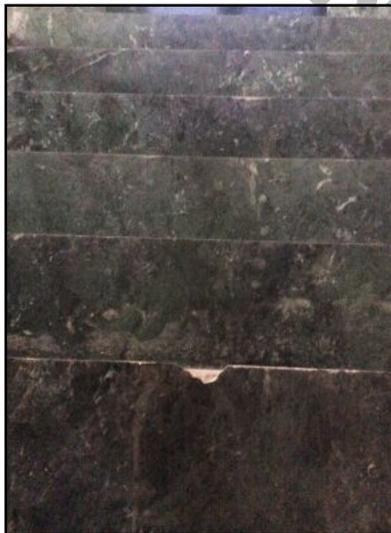
- Broken step at the staircase recommend to maintenance to repair/replace.

Broken edge

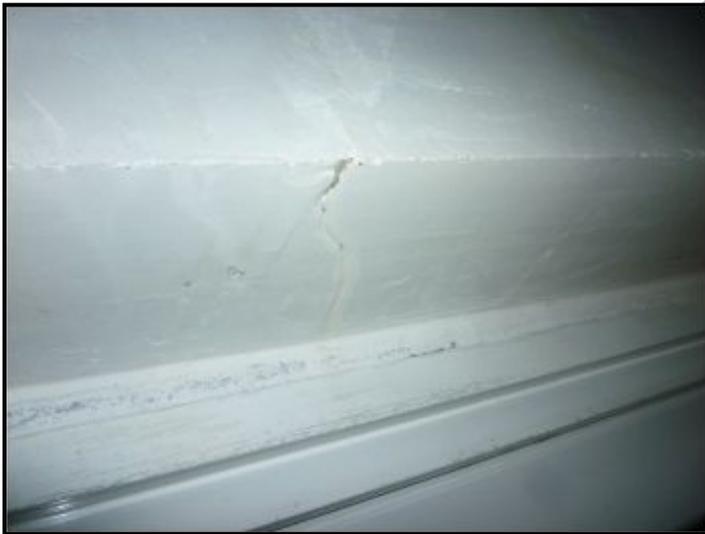
- The finishing above the door reveal is improper , recommend proper sanding before paint finish.
- Seepage patch followed by pathway/groove at right wall above sliding window. These may be due to some work done at the balcony of the floor above, recommend brushing off the existing patches and application of primer based POP.
- Vertical crack at front wall near alley of bedroom 1 and 2, recommend sanding and filling with liquid putty.
- High moisture content noted at the front wall near alley of bedrooms 1 and 2, any wood work done at this wall may be given a water proof coat.

Seepage patch above sliding window

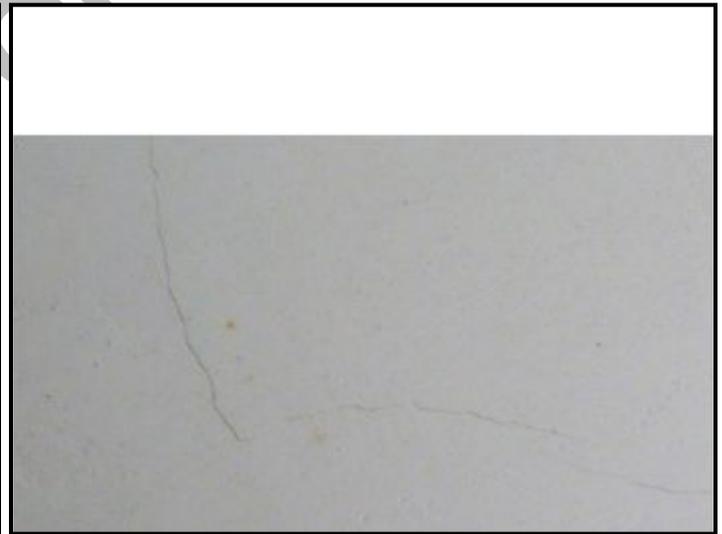
Vertical crack at front wall near alley

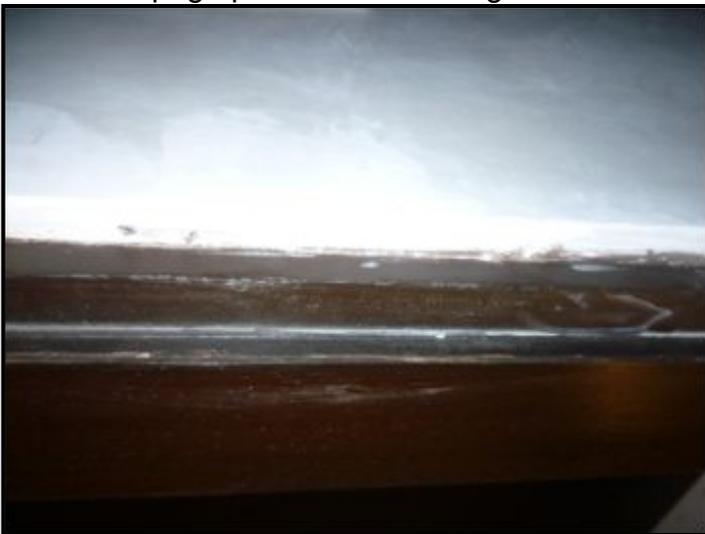
Improper finish at door reveal

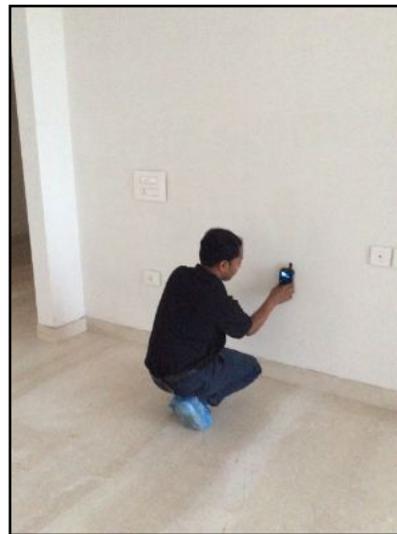
High moisture content

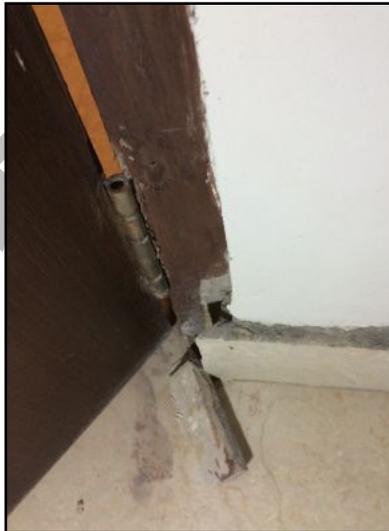
- The skirting behind the entrance door is broken since the stone is laid beyond the wall, the stone needs to be replaced and a small buffer may be installed

Broken skirting

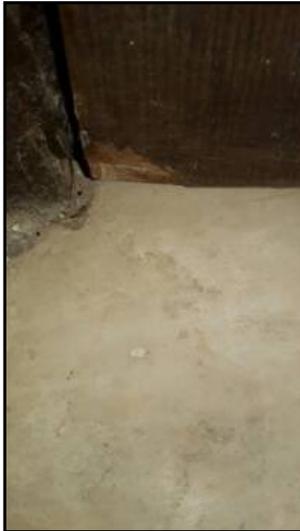
Chip at panel at bottom corner side

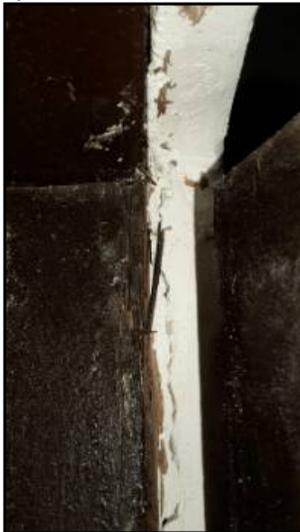
Broken wood at left frame top side

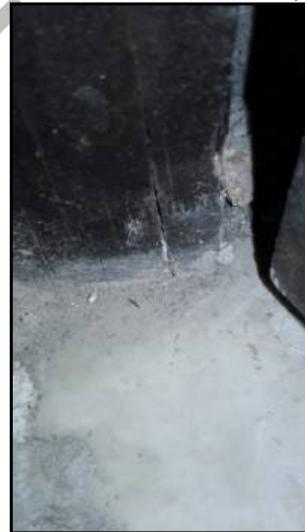
Crack at left frame bottom side

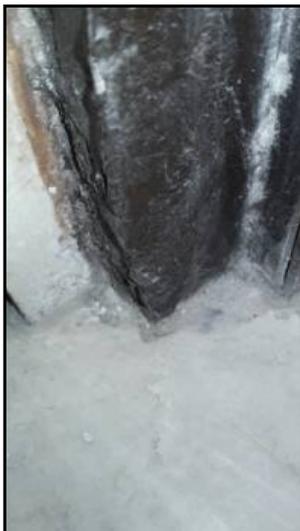
Improper finish at right frame bottom side

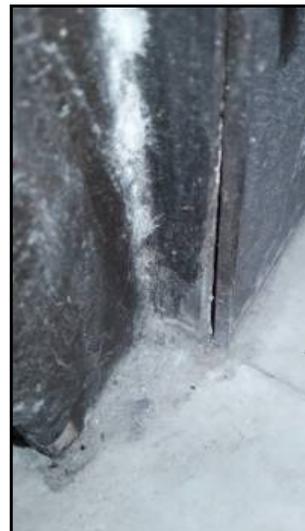
Gap at right frame joints at bottom side

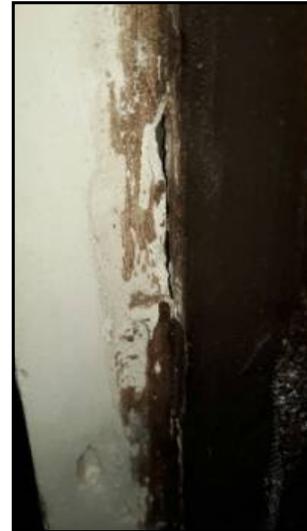
Improper filling at frame and wall inside

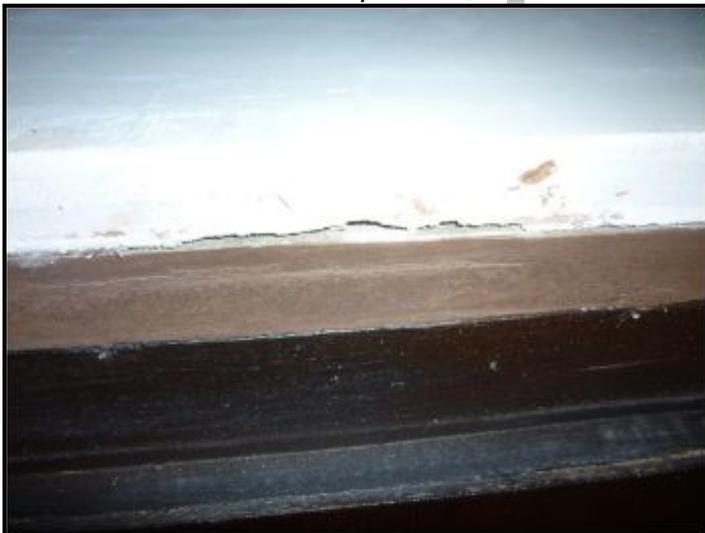
Gap between frame and wall

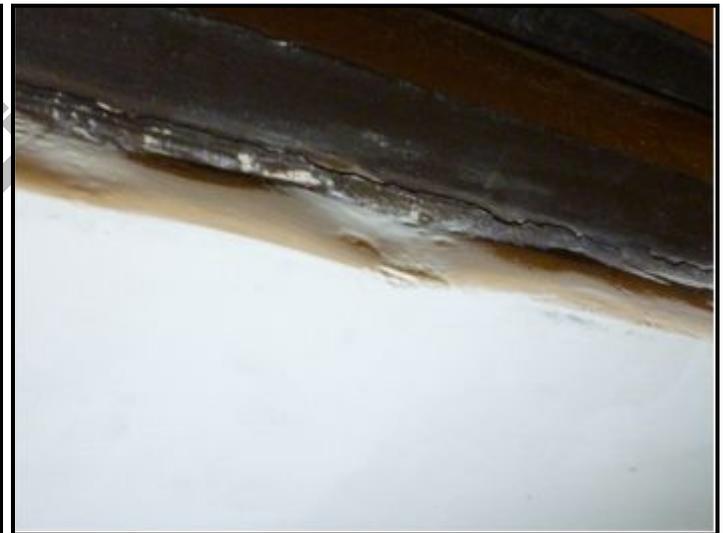
Improper finish at door reveal

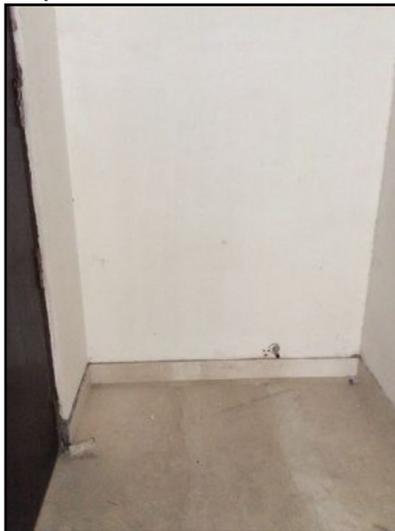
Improper location of buffer

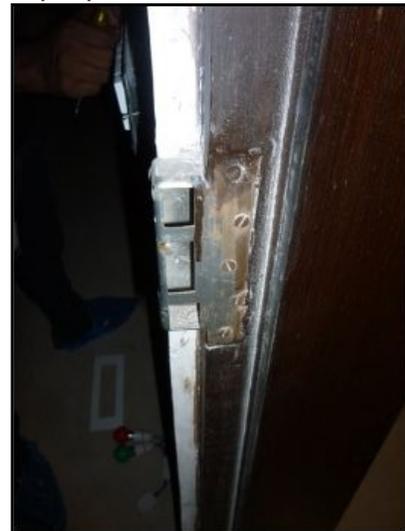
Improper filing at groove plate position.

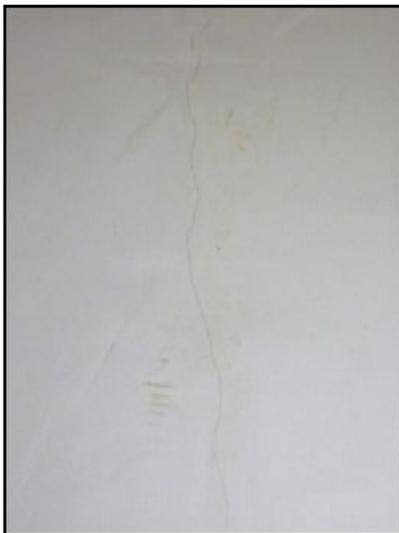
Vertical crack at left wall near right wall

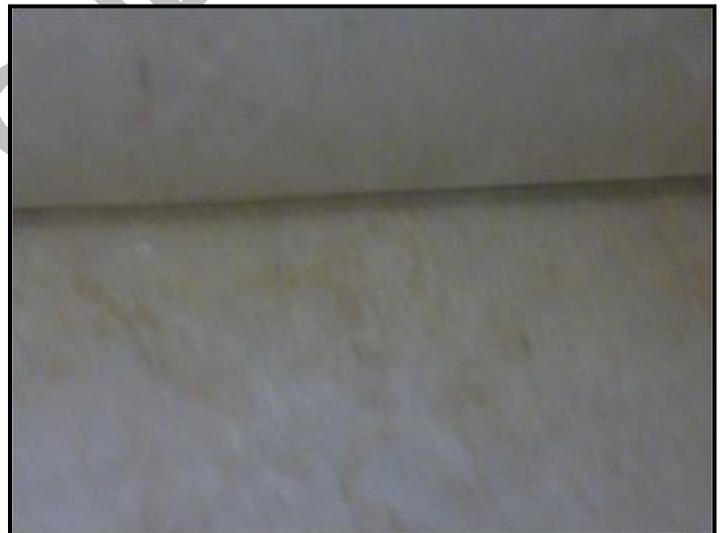
Improper filling at the gap between skirting and flooring at front wall corner

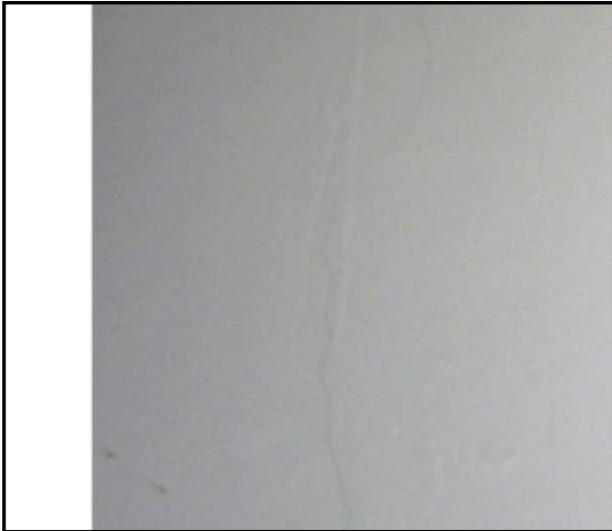
Vertical crack at front wall of alley from beam

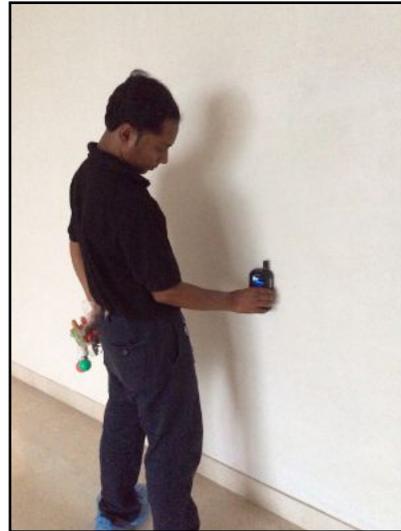
High moisture at back wall corresponding to kitchen

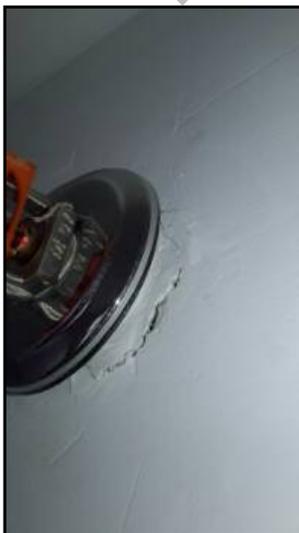
Improper finish around sprinkler at right wall

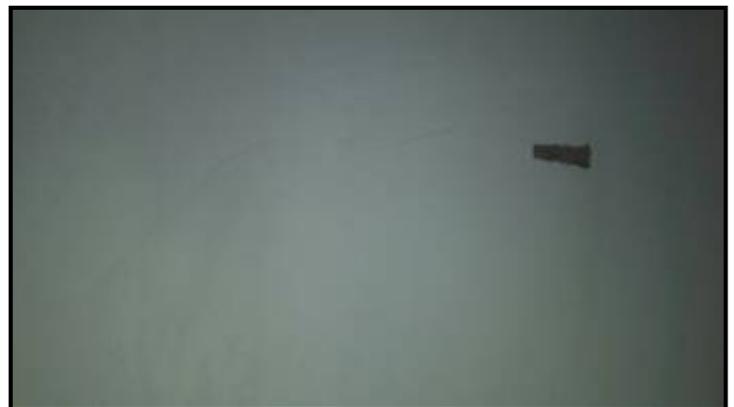
Shrinkage crack and peeling of POP at front wall near right wall

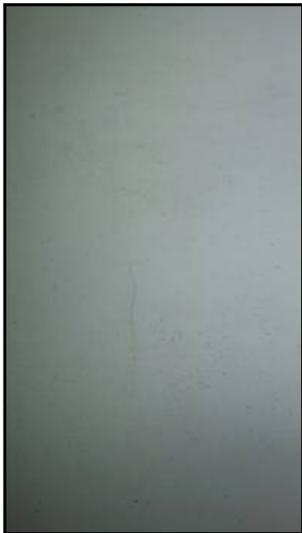
Diagonal and vertical cracks at front wall near the joint with right wall

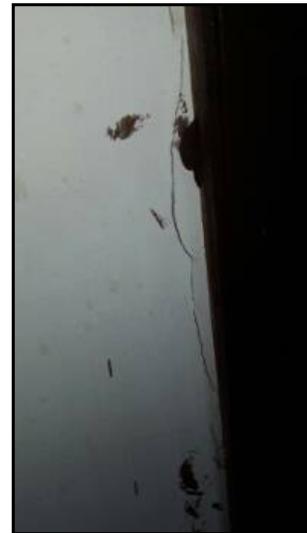
Vertical crack at back wall near left side of bathroom door frame

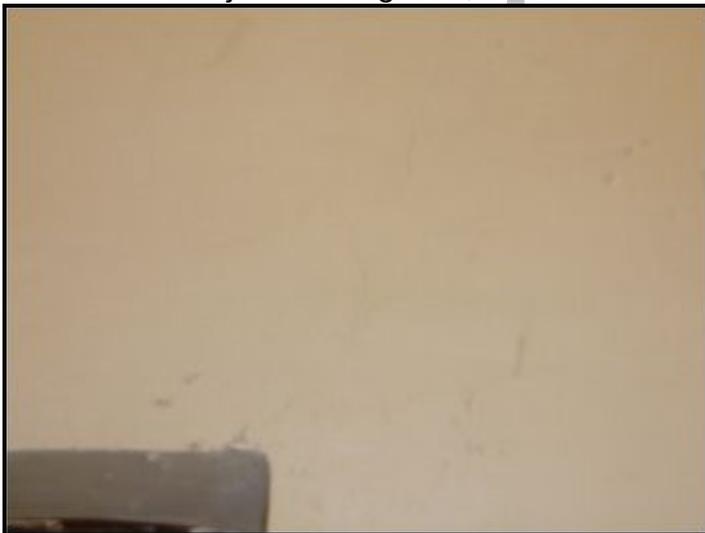
Diagonal crack at back wall above door frame

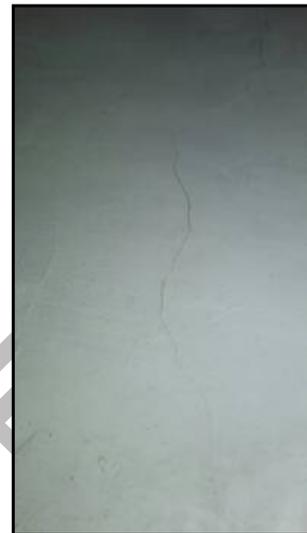
Vertical crack at back wall above door frame

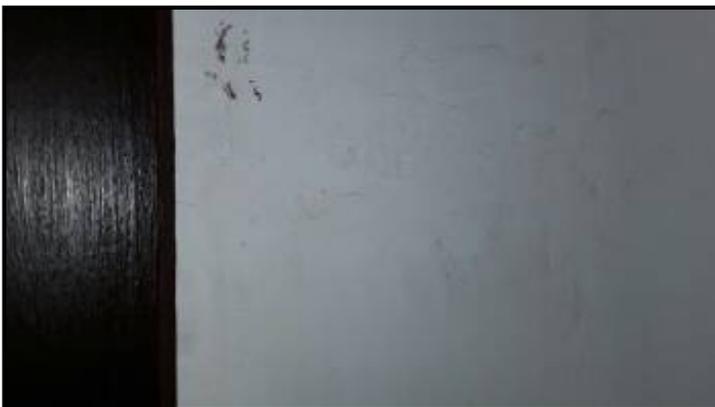
Improper finish at back wall near bathroom right door frame

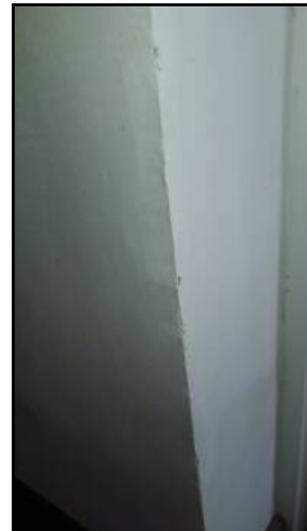
Improper finish at left wall edges

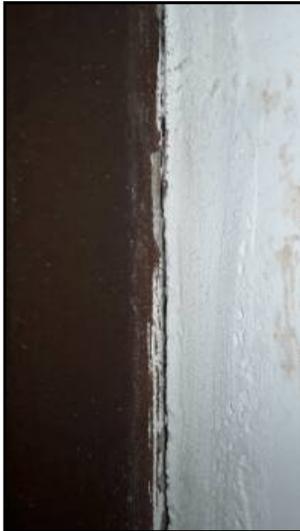
Improper filling between frame and wall

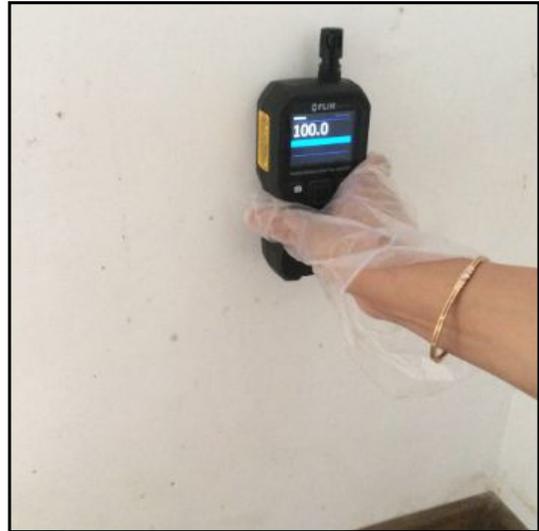
High moisture content

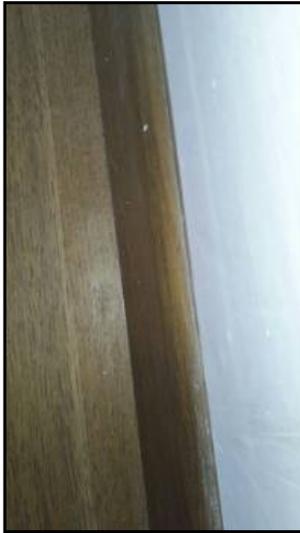
Gap at beading and wall at several places

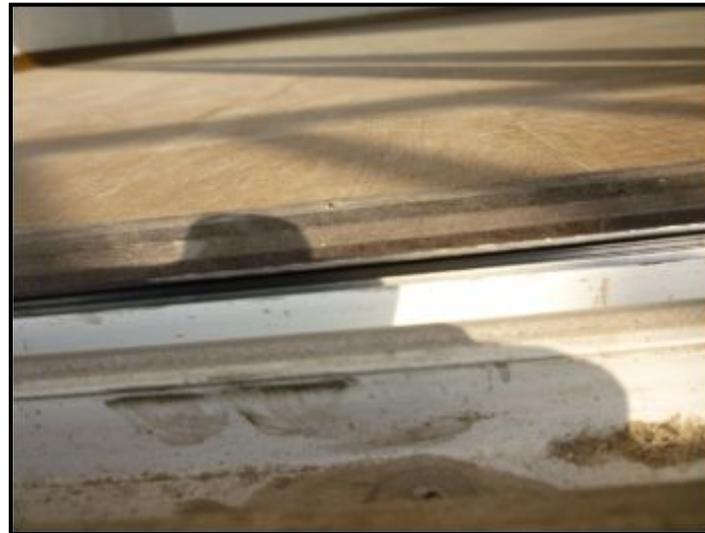
Floor transition improperly installed at sliding door as having gap with sliding door's bottom channel

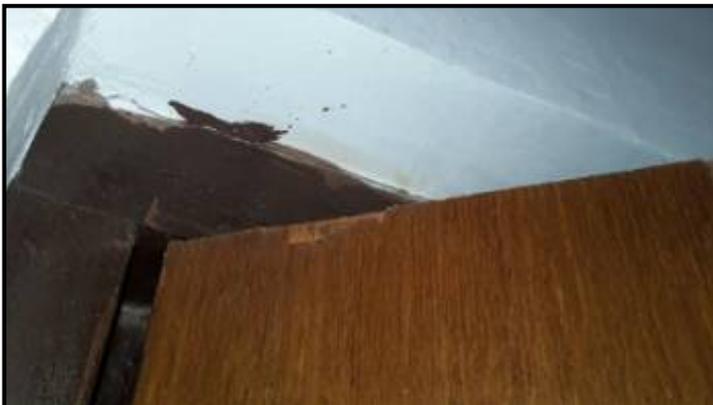
Chip at panel top side

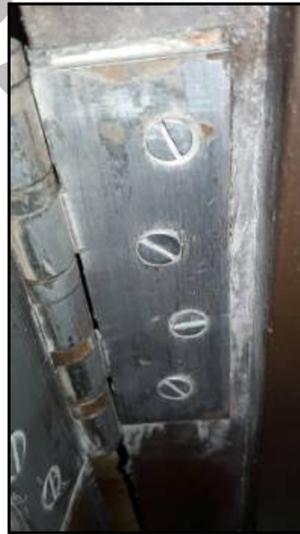
Right frame bottom hinge has not been installed properly

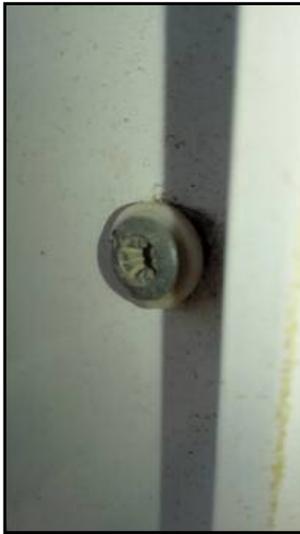
Some screws at balcony door frame have not been fixed properly

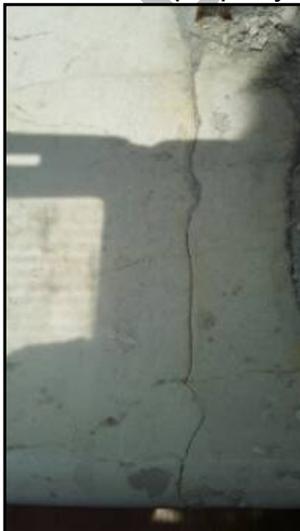
Multiple cracks at marbles at railing sill top at balcony

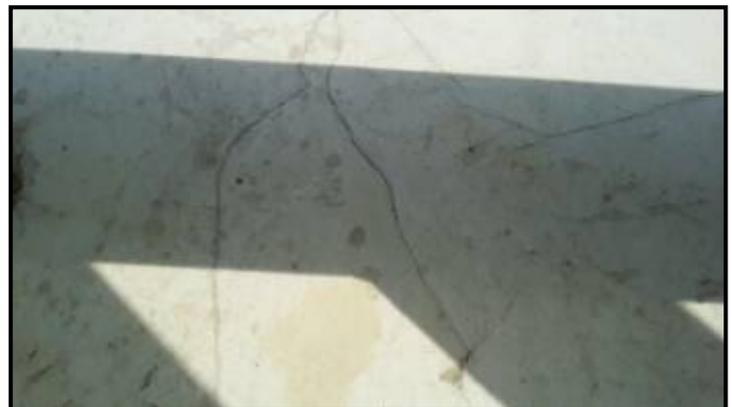
Multiple cracks at marbles at railing sill top at balcony

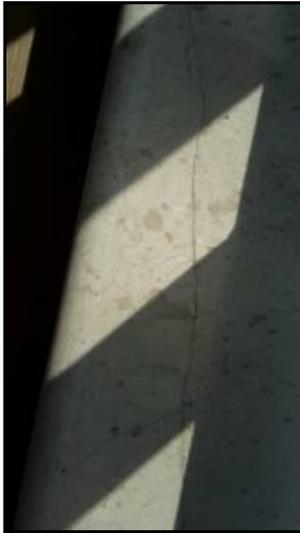
Multiple cracks at marbles at railing sill top at balcony

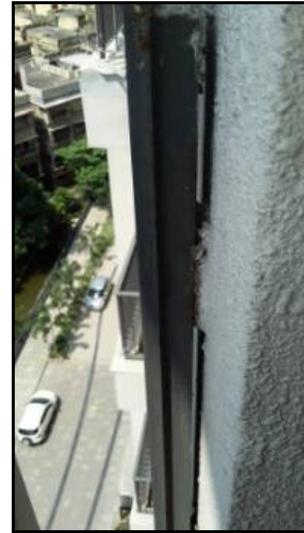
Gap at right wall and railing

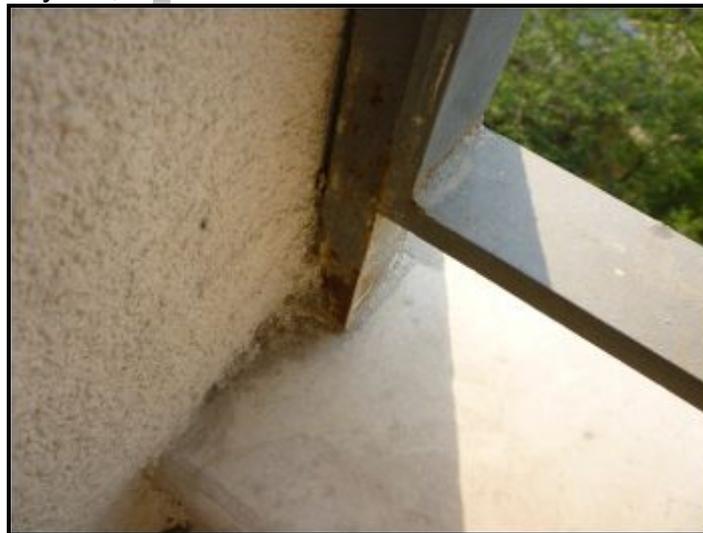
Railing is getting rusted

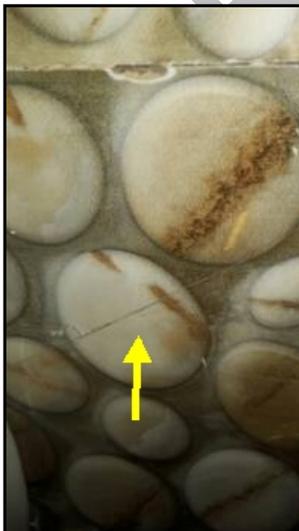
Crack at front wall tile near wc

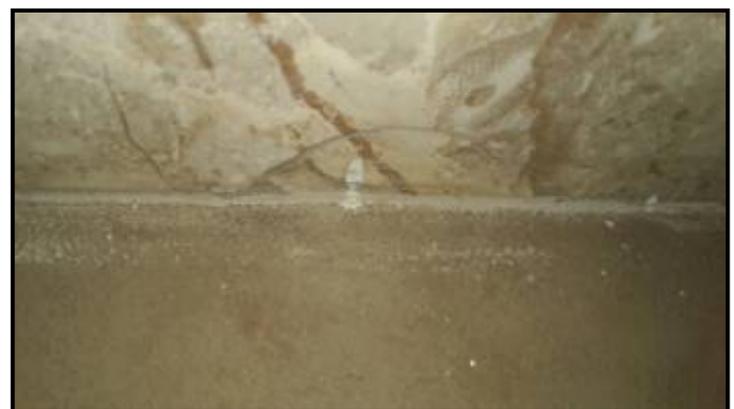
Crack at back wall bottom side behind door

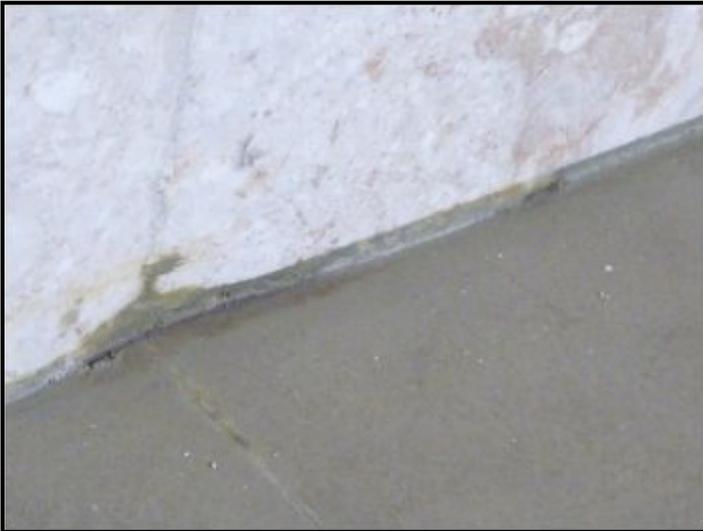
Gap between wall tiles and floor tiles at left wall wet floor

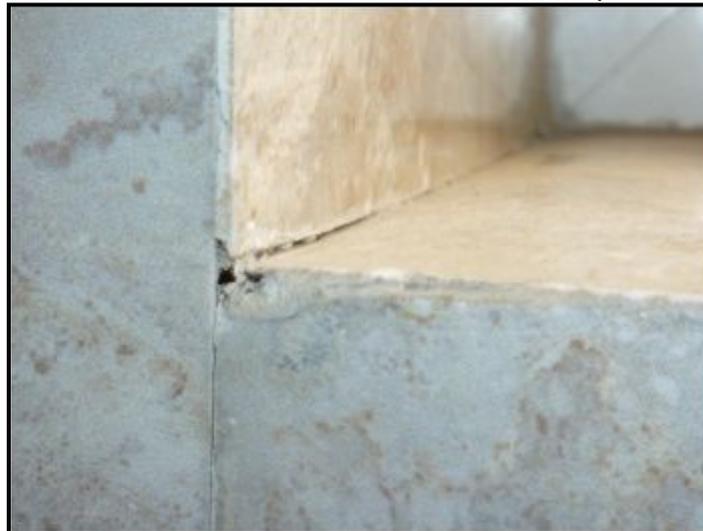
Improper filling at left window sill corner

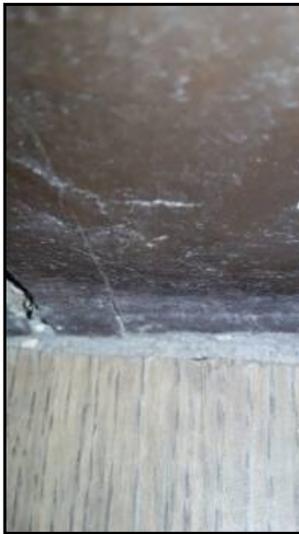
Crack at left frame bottom side

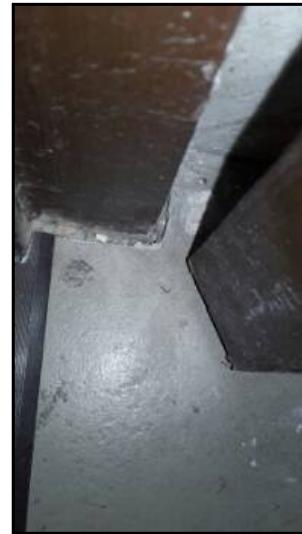
Gap at frame and floor inside bathroom

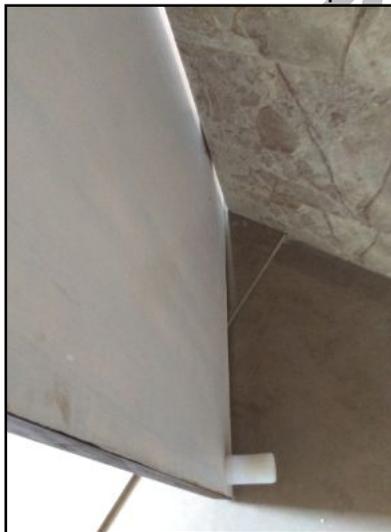
Improper position of door buffer

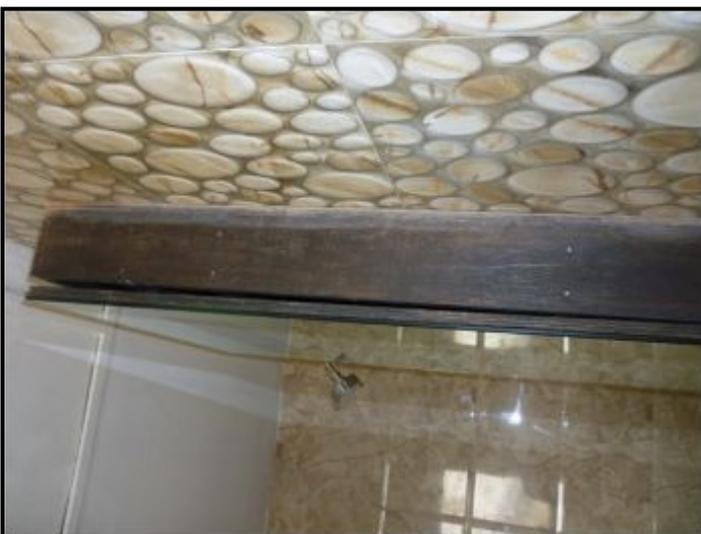
Swing panel having gap at top due to misalignment

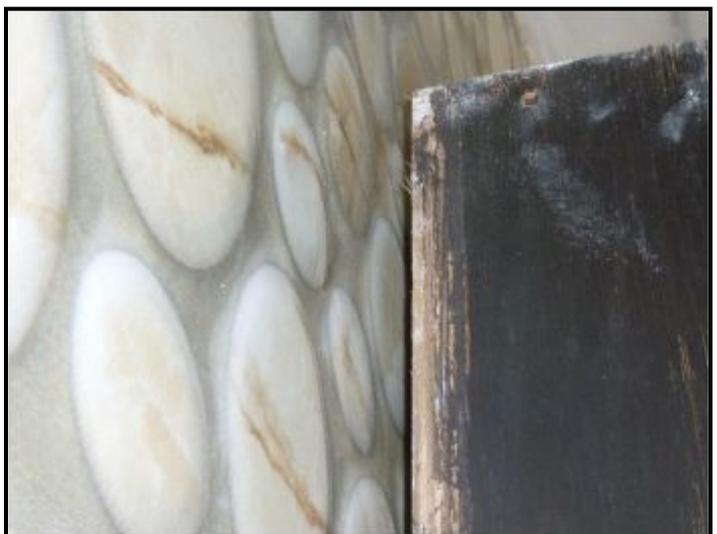
Gap between wall and cabinet at top left corner due to improper installation

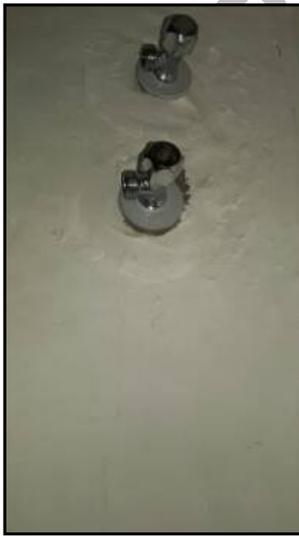
Improper finish and popping at right wall around geyser knob

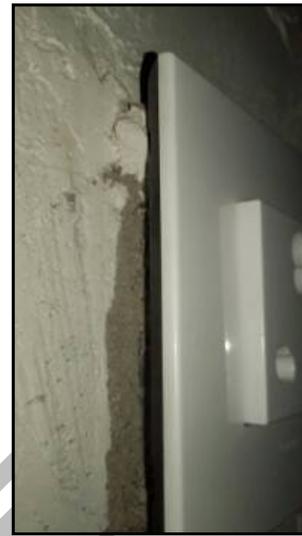
Geyser socket has not been installed properly at back wall

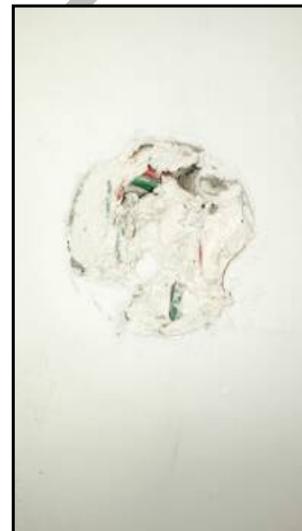
Improper finish at left wall around electrical circular point

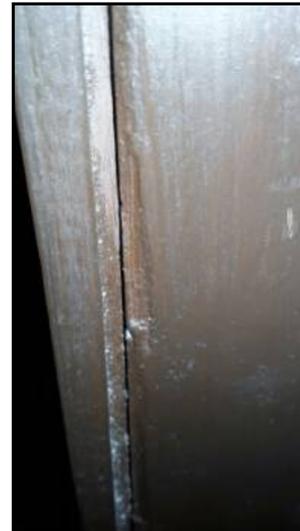
Improper finish at left frame

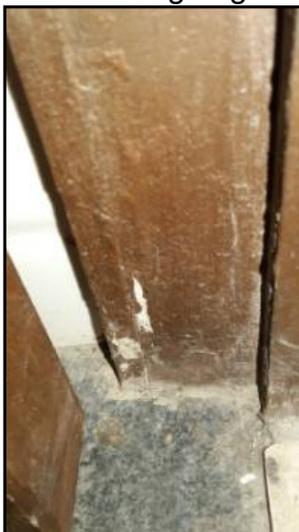
Crack at right frame bottom side

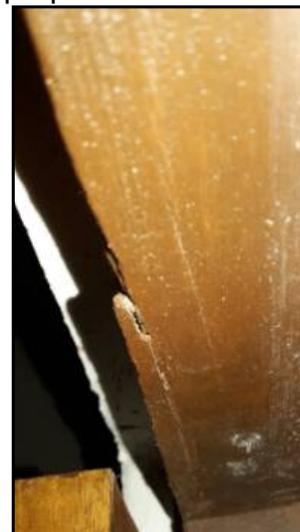
Wood broken at top frame

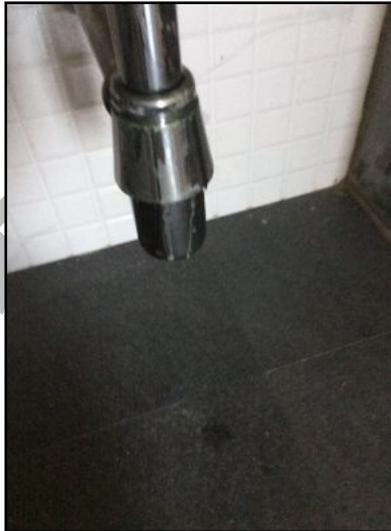
- FYI - The main water shut off valve at the balcony inside duct.
- **Leak at the bottle trap to be repaired.**

Leak at the trap

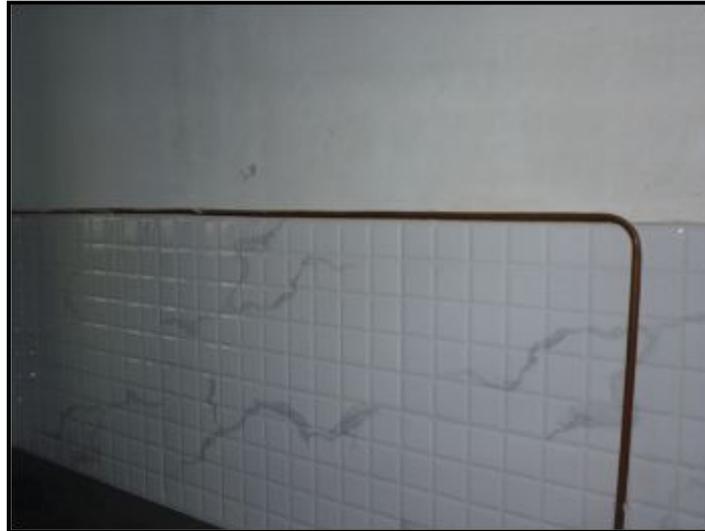
- **Bare LPG pipe, recommend a paint coat.**

Unpainted gas pipe

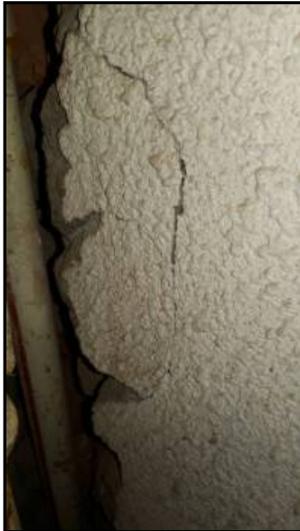
Crack at plaster

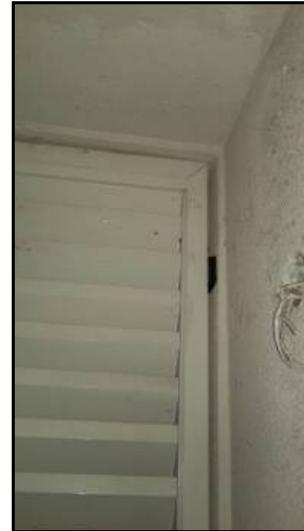
Gap at window frame and wall

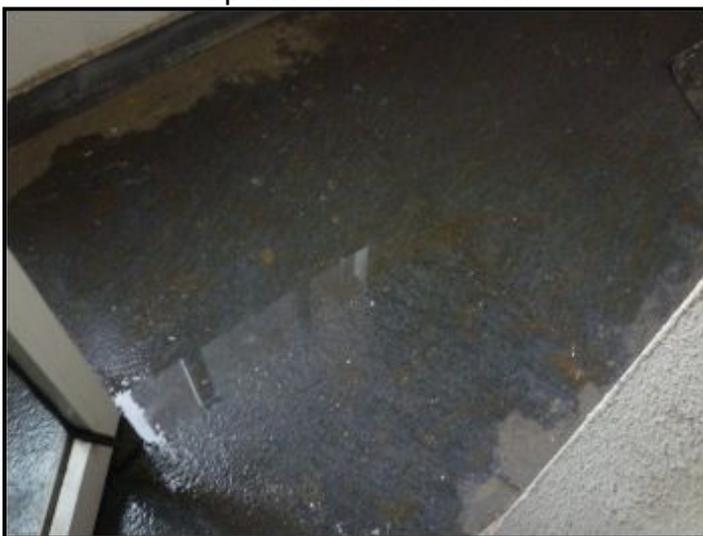
Water accumulation observed at middle of floor due to improper slope

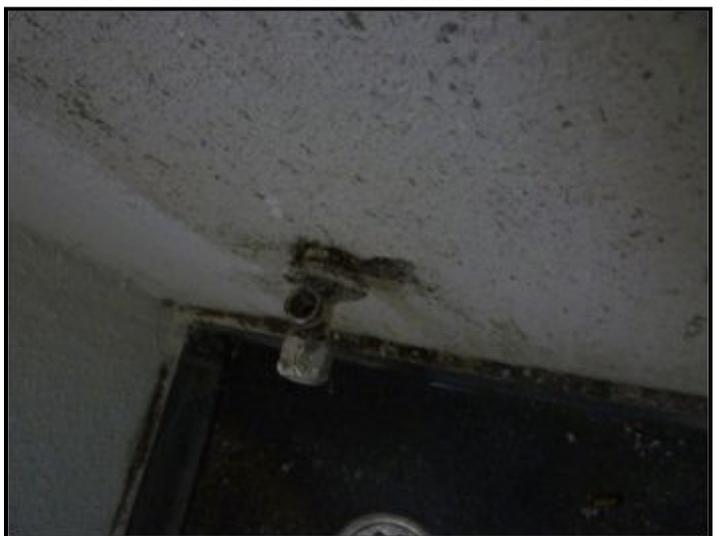
Water tap valve improperly installed at right wall

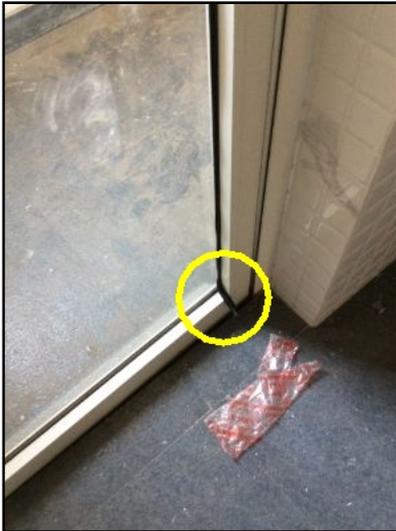
Improper gasket

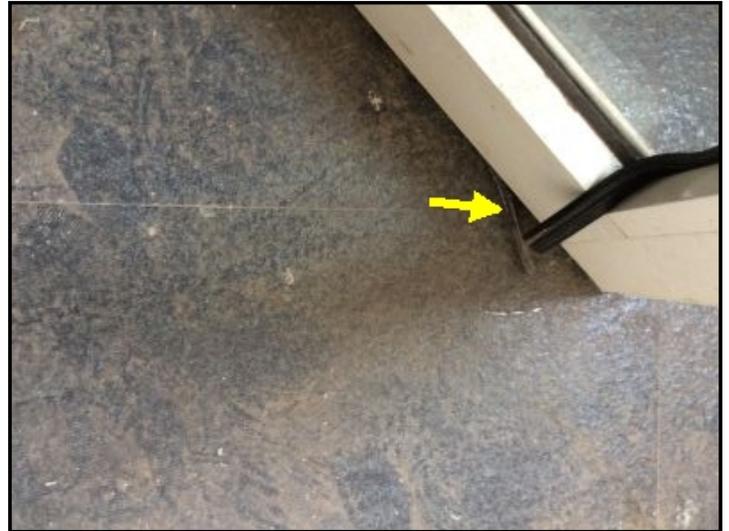
Obstruction under the door

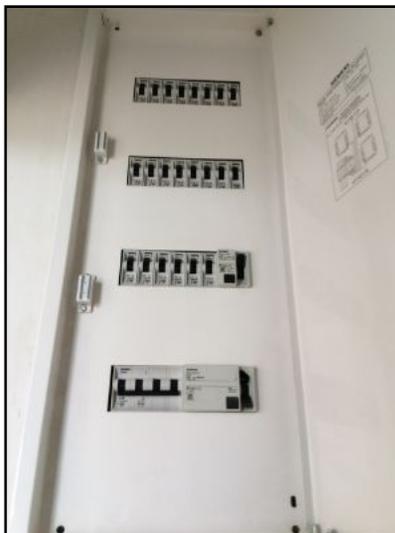
Distribution box

- Three screws have not been fitted at D.B ,recommend installation.
- Lugs have not been provided for wire connection at D.B ,recommend installation for tightness and longevity.
- Most metal boxes at various rooms are rusted and dirty , recommend cleaning and red oxide primer painting.
- Colour code for wiring has not been followed ,recommend review.
