MACJ - A Buyer's Choice Home Inspections

Property Inspection Report

Unit XYZ, EM Bypass, Kolkata, West Bengal 700054

A 4BHK apartment in a multi- building complex in east Kolkata region

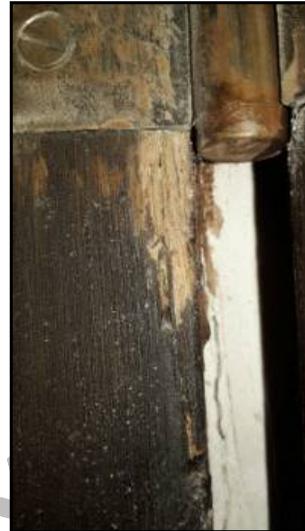
- Chip at panel at bottom corner side, recommend filling by colour matching wooden filler.
- Chip at left frame below top hinge, recommend filling by colour matching wooden filler.

Chip at left frame below top hinge

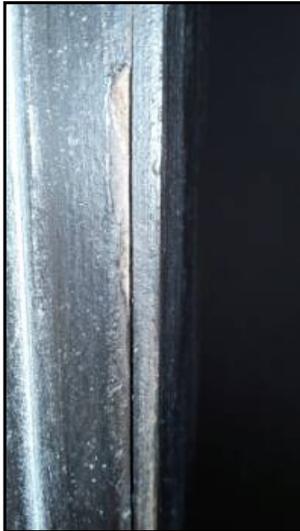
Gap at right frame joints at bottom side and middle portion

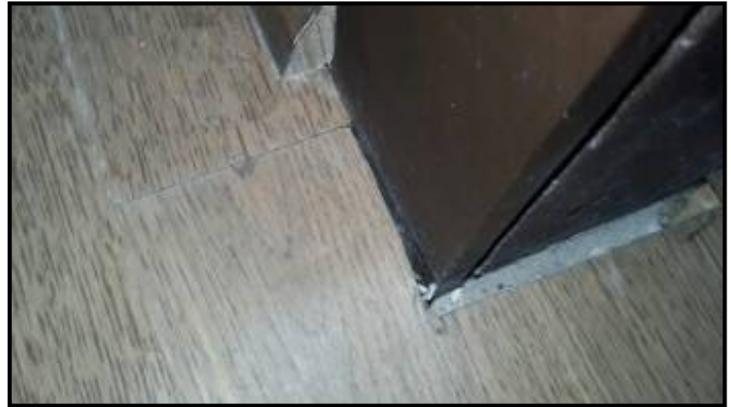
Gap at floor laminate and bathroom 1 door frame

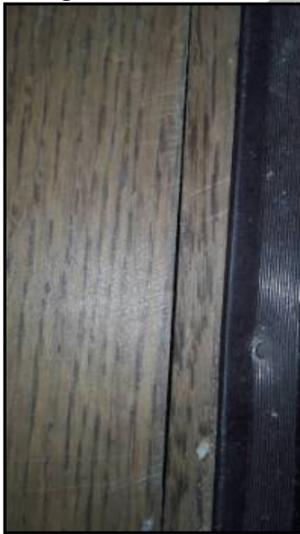
Gap around wooden laminate near bathroom 1 entrance

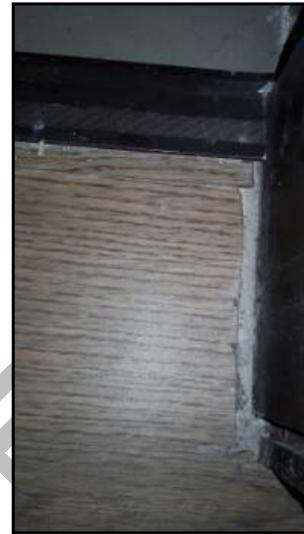
Gap at floor laminate and bathroom 1 door frame

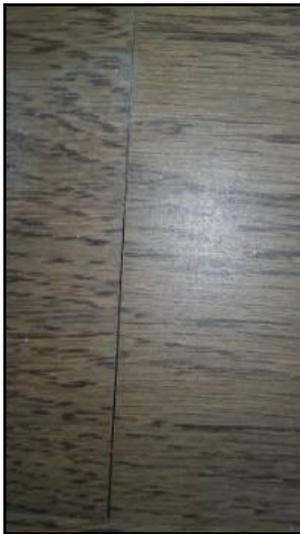
Gap at several places at wooden laminate

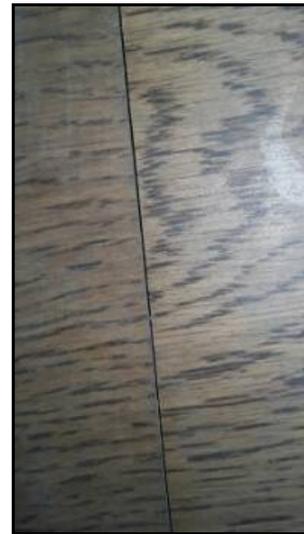
Gap at several places at wooden laminate

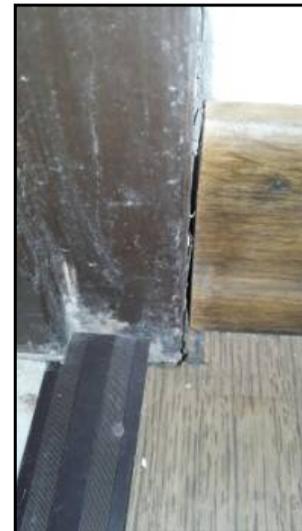
Gap at beading and frame and at flooring and frame

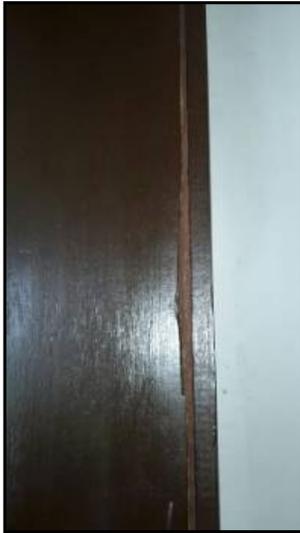
Uneven gap between beading and right frame

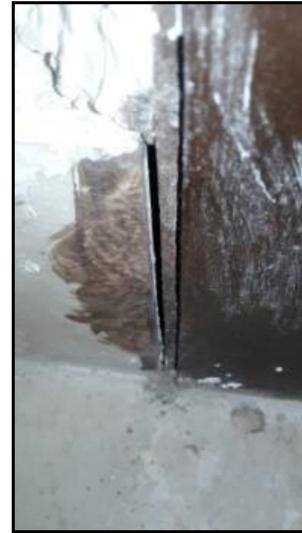
Gap at skirting and left frame.

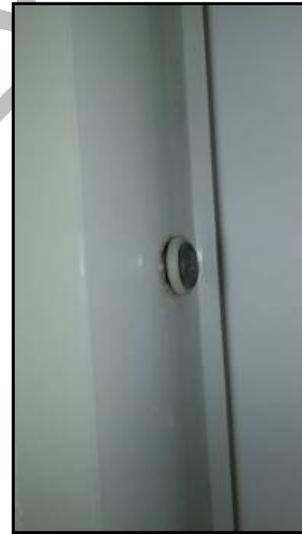
Some screws at balcony door frame have not been fixed properly

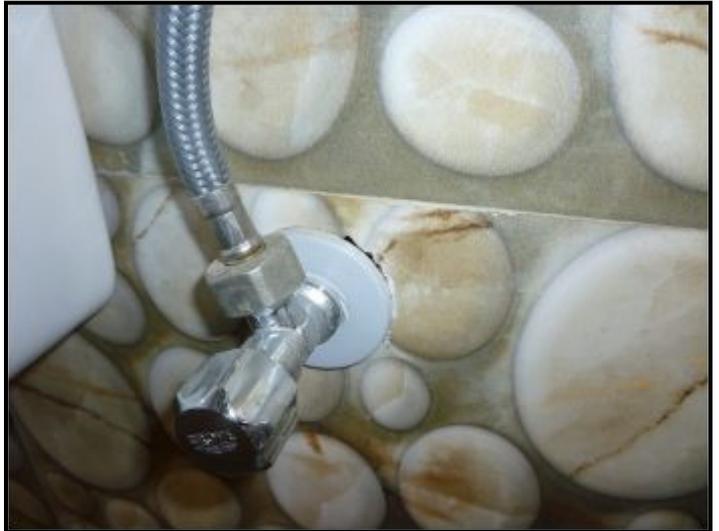
Tile cut extra around sink valve

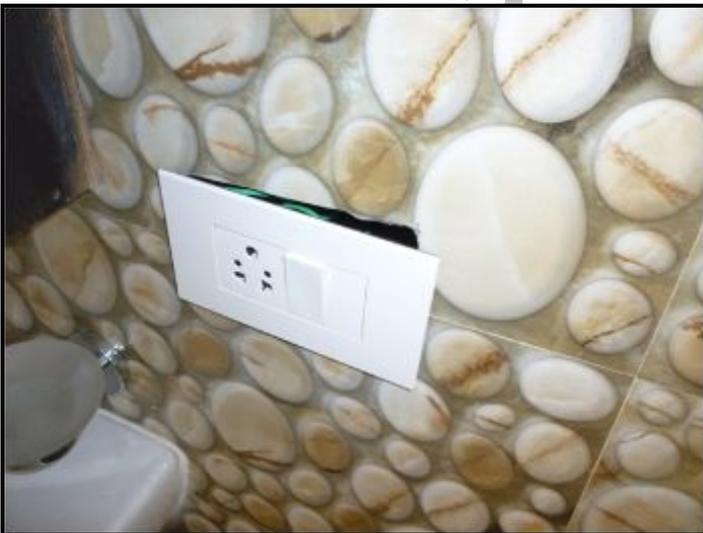
Tile cut extra at front wall socket

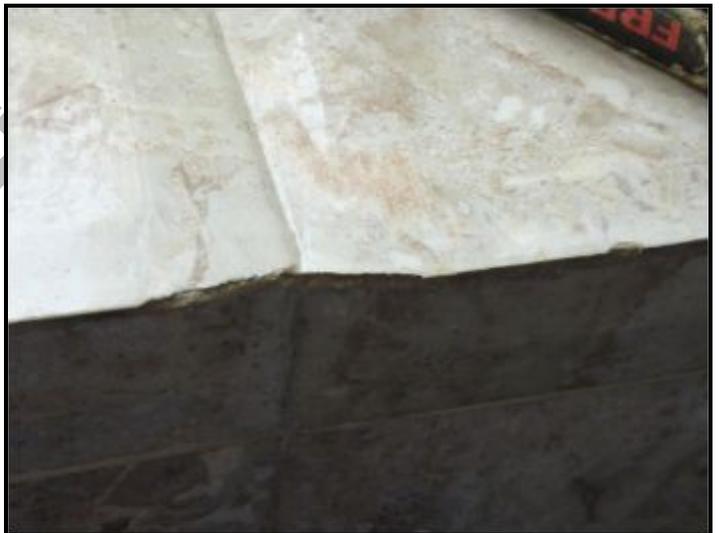
Chip at window sill edge

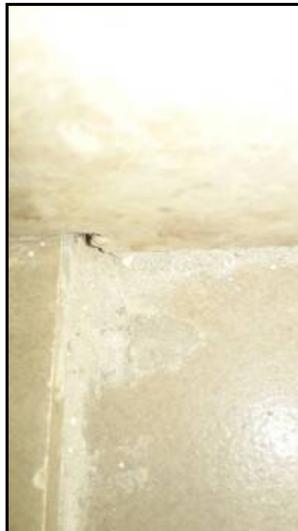
- Chip at tile, recommend review.
- Gap at floor and wall at back wall, water may seep in from such gaps, recommend filling with sealant.

Gap at floor and wall at back wall

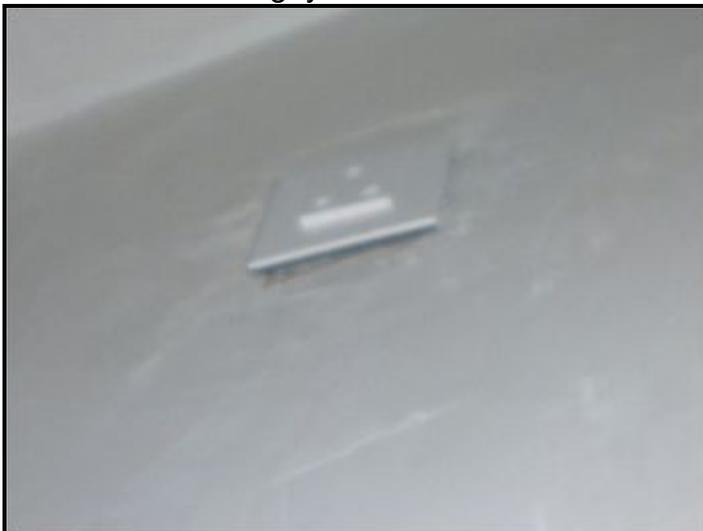
Geyser socket point concealed casing is up mounted at one side

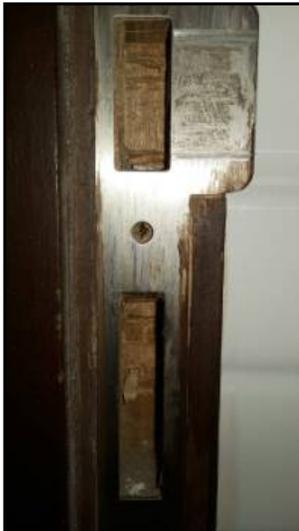
- Wooden door
- Improper finish at left frame, recommend putty finish.
- Screw missing at groove, recommend to install.
- Crack at right frame bottom side, recommend filling by colour matching wooden filler
- Wood broken at top frame, recommend review.

Screw missing at groove

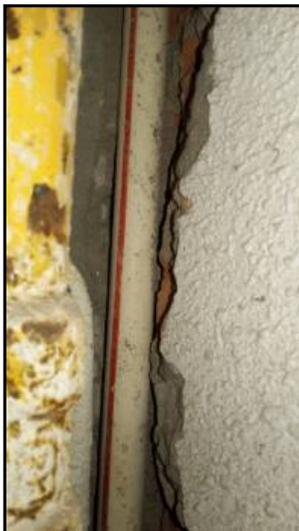
- Gap at duct and left wall to be reviewed.
- Washing machine valve improperly installed.
- Open wall at the concealed pipe to be covered/ replastered so water does not seep in the wall.
- Lpg meter has not been installed properly ,recommend fixing the nut bolts properly.
- Crack at plaster at back wall near right corner ,recommend sanding and filling by liquid putty.
- Gap at window frame and wall at top and right side, recommend filling with architectural sealant.
- No screws have been installed at the duct cover, recommend fixing of screws.
- Water accumulation observed at middle of floor due to improper slope, recommend review and necessary repair since this is a wet area.
- The door gasket is improperly installed to be repaired.
- The door is difficult to operate due to an obstruction under the door recommend review.

Conceal pipe is seen at back wall right corner

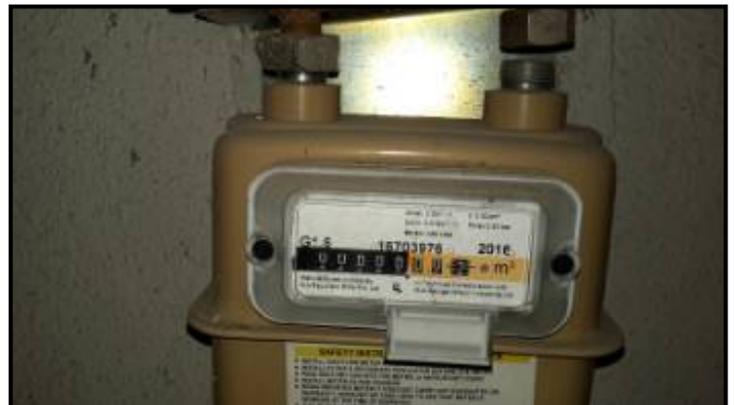
Lpg meter has not been installed properly

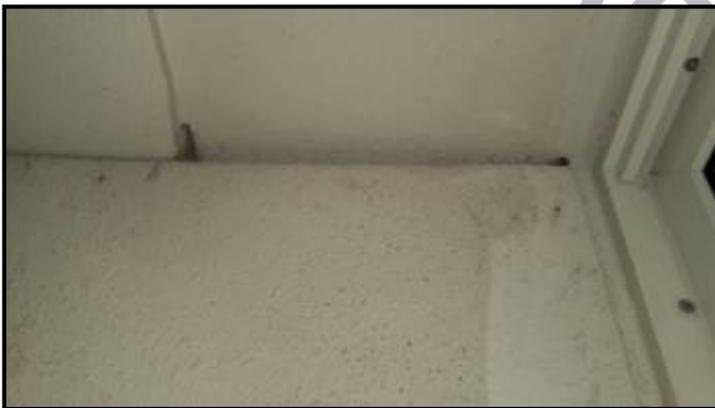
Gap at duct and left wall
